Vibrations and Museum Collections, Part 1

The Effects of Vibrations from Human Traffic and Construction on Museum Collections

By Arne Johnson and Mohamed ElBatanouny

Case Study: The SUE Gallery

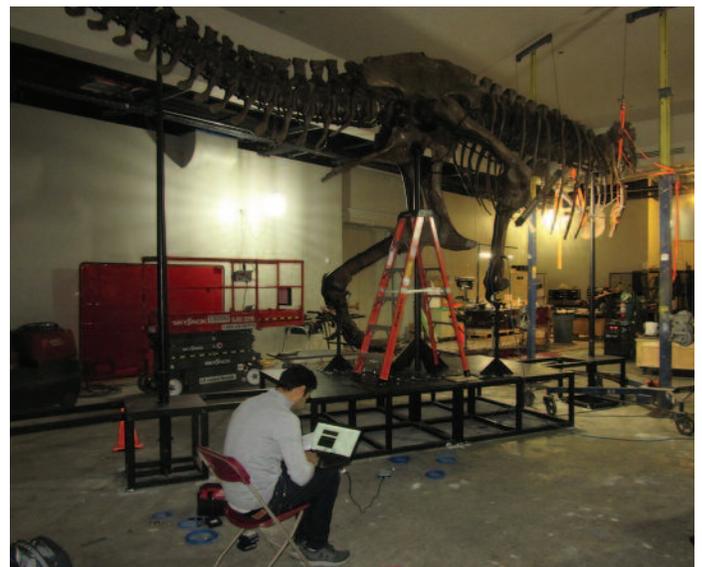
Figure 2. Vibration testing underway in the new SUE gallery during gallery construction.

About 20 years ago, the light well was filled in with three levels of steel-framed, lightweight concrete floors spanning approximately 39 feet between original load-bearing masonry walls (Figure 2). The floor structure at the new location was

The Field Museum engaged the authors' firm to perform vibration testing at the previous and new exhibit locations. The testing confirmed the museum's concerns. Floor vibrations from human activities and scissor-lift operations at the new exhibit location were three to six times greater than in SUE's previous location, and the natural frequency of the floor at the new location was approximately 6 Hz, compared to approximately 13 Hz at the previous location. The lower natural frequency of the floor is much closer to the pace of human walking, which creates the potential for dynamic amplification (resonant-like behavior) during human activities.

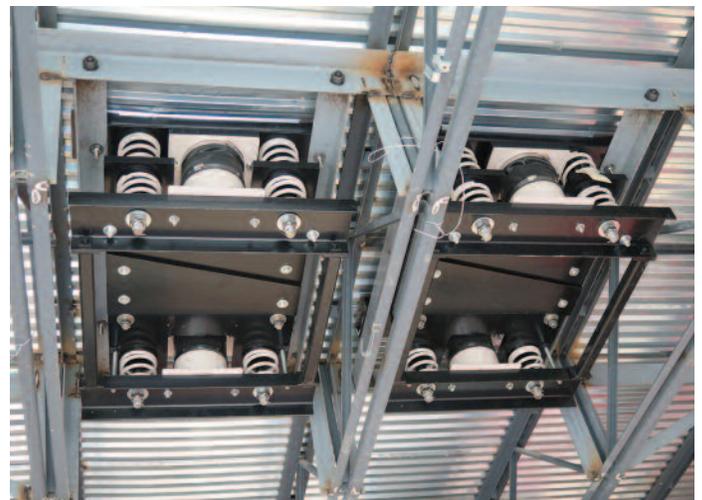
Figure 3. Example of TMD suspended below a floor structure.

A tuned mass damper (TMD) is a device with a mass supported by a spring and damping mechanism which, when tuned to a dominant floor frequency, can significantly reduce the amplitudes of load-induced vibrations at that frequency. For the subject case, TMDs would be suspended from the floor adjacent to the existing girders below SUE (Figure 3).

By tuning the vibration characteristics of the TMD to the floor structure, the TMD counteracts the resonant or harmonic response of the floor at the targeted frequency. A TMD system typically performs best for floors with a single dominant mode of vibration and minimal participation from other nearby response modes.

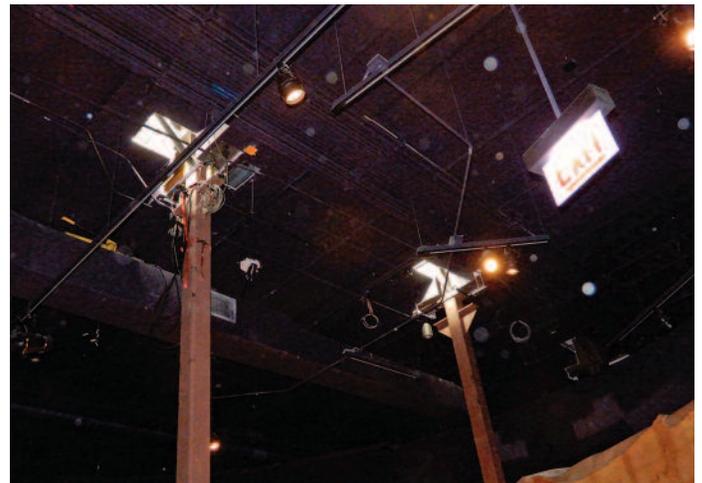
Figure 5. View from below of two of the three supplemental columns installed below the SUE gallery.

During construction, WJE operated hydraulic rams and digital instrumentation to preload the columns (Figures 5 and 6), which ensured tightness of the system and pre-compression of existing soils below the new spread footings. The new columns were 8x8-inch structural steel tubes with shop-welded brackets at their heads to facilitate the hydraulic preloading.

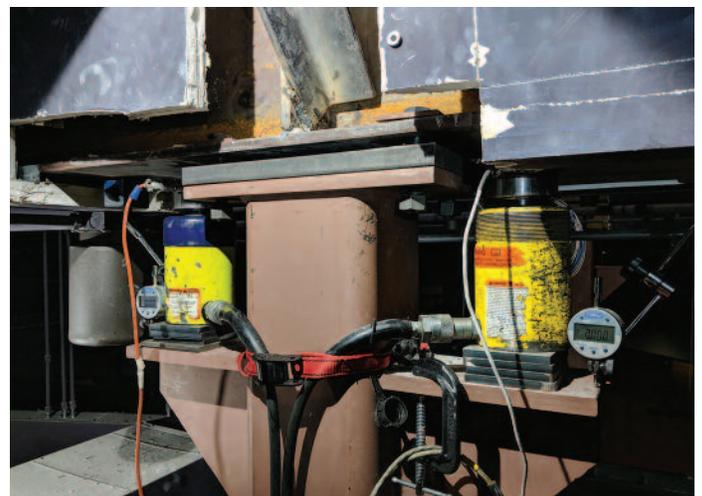
Figure 6. Close-up of top of column during hydraulic preloading.
