BY LEAH M. RUTHER, P.E.
Wiss, Janney, Elstner Associates, Inc.

Become familiar with general components and conditions that might alert you that trouble is on the horizon with your light pole inventory.

Maintaining Your Light Pole Inventory for Longer Service Life

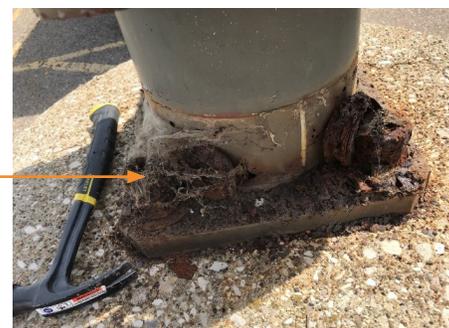
Figure 6. Same pole from Figure 5, with base plate cover removed, revealing corrosion and debris.

Similarly, anchor bolt and base plate covers, while serving an aesthetic purpose, can trap debris and moisture which can lead to corrosion of the pole (described further below), base plate, and anchor bolts (Figure 5 and Figure 6).

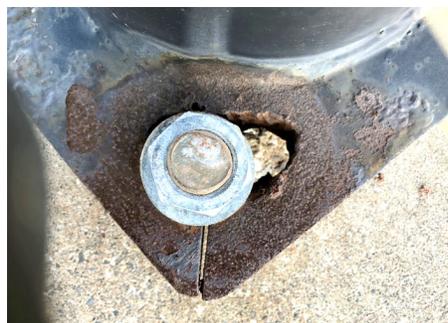
Figure 7. Oversized bolt hole.

A base plate serves as the interface between the steel structure and the foundation and is designed to transfer forces into the anchor bolts and foundation. The base plates must resist wind from tipping over the pole assembly by pulling up on one or more nutted anchor bolts. If holes in the base plate are oversized relative to the diameter of the anchor bolt and nut (Figure 7), a pull-through failure may occur which would destabilize the light pole. Washers may be introduced as part of the design or to accommodate over-sized holes, however the washers require proper design in order to adequately transfer loads without deformation (Figure 8).

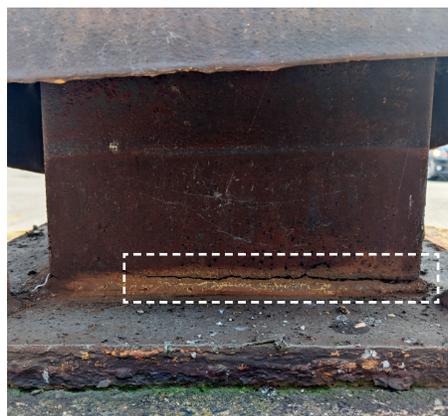
Figure 10. Crack at welded connection to base plate of square pole.

at both the top and bottom of the base plate transfer loads from the pole and luminaire to the base plate. Weld cracks are most often the result of cyclical wind loading of light poles. Based on WJE's experience, square profile poles with fillet welds made using a manual process are most prone to weld cracking (Figure 10), with the risk increasing as pole height increases. Square poles experience stress concentrations at the corners, whereas round poles allow for a more even distribution of stress. While cracks can be readily visible, specialized nondestructive techniques, such as a magnetic particle testing, can aid in identifying early-age cracking.

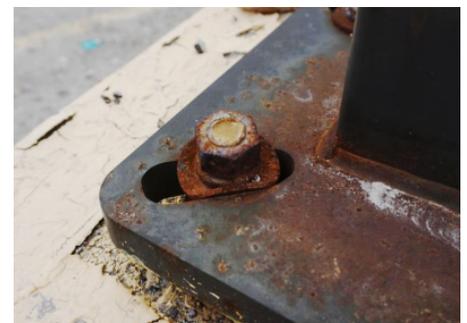
Figure 8. Deformed washer.

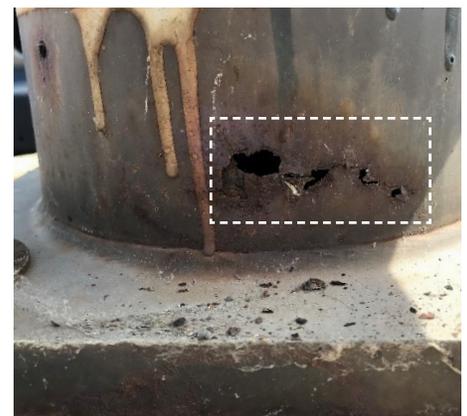
Figure 11. View of exterior base of pole through section loss due to corrosion.

The typical parking lot pole that is the subject of this article is made of mild steel and, as such, is subject to corrosion and associated section loss, which often manifests at the base (Figure 11). While

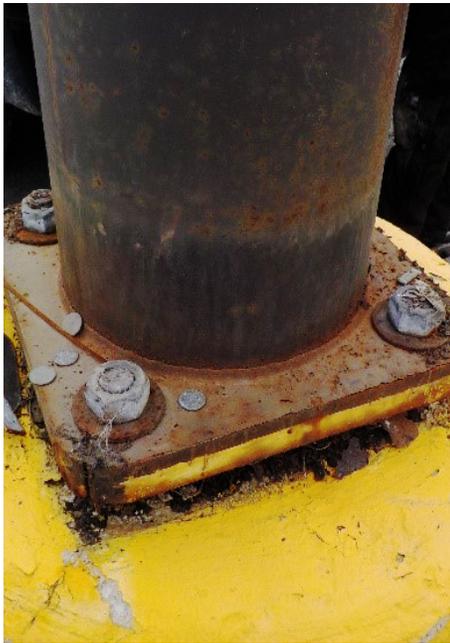
Figure 12. Exterior view of subject pole.

As noted above, water and debris that may collect inside a pole at its base often enters via the open space below the base plate, through the hand hole in the pole, or other pole openings. This accumulation can cause or accelerate corrosion on the interior surface of the pole. Even when severe, interior corrosion may be visually undetectable from the exterior. A pole can appear to be in good condition from the exterior yet may have significant section loss at the base of the pole from inside-out corrosion (Figure 12, Figure 13, and Figure 14). Ultrasonic thickness gauges can be used from the exterior to measure

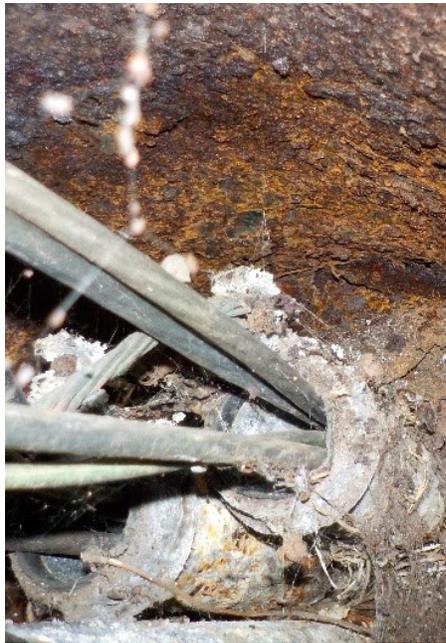
Figure 13. Interior view of subject pole.
