BY GARY S. WENTZEL

Wiss, Janney, Elstner Associates, Inc.

The Disruptive Potential of Pyritic Shale Fill

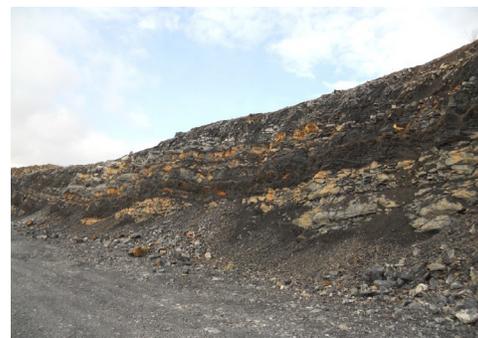
FIGURE 1. A PYRITIC SHALE FORMATION IS EXPOSED AT A QUARRY FACE. WITHIN THREE YEARS OF EXPOSURE, OXIDATION OF THE PYRITE HAS LED TO IRON OXIDE STAINING AND DEGRADATION OF THE SURROUNDING SHALE.

Many forms of pyrite are stable. However, framboidal pyrite readily degrades when exposed to air and moisture. Black shales with inherently weak bedding planes typically offer little protection of embedded framboidal pyrite particles. Potential for exposure is increased if the pyrite-containing material is broken up (e.g., by crushing to produce aggregate, or by excavation, placement and compaction when used as fill). Placing material in a new environment can also increase exposure potential. Exposed pyrite reacts with the air and moisture in an

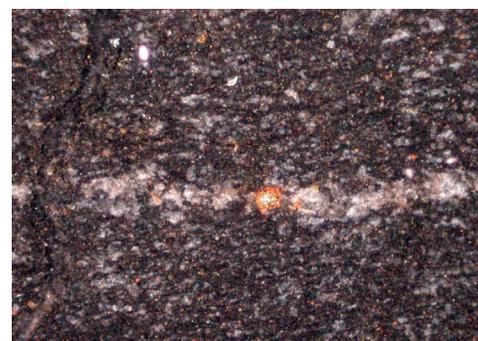
FIGURE 2. A RELATIVELY THICK BEDDING PLANE CONTAINED IN A SHALE FRAGMENT IS PICTURED. A BRASSY YELLOW PARTICLE COMPOSED OF IRON SULFIDE IS LOCATED WITH THE RELATIVELY THICK WHITE LAYER.

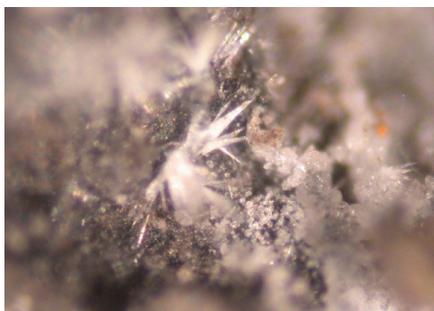
FIGURE 3. A MICROGRAPH OF GYPSUM CRYSTAL GROWTH WITHIN AN OPEN BEDDING PLANE IN THE SHALE PARTICLE.

The sulfuric acid (H_2SO_4) by-product of pyritic degradation can react with the calcium carbonate ($CaCO_3$) component inherent to common fill material such as limestone to form gypsum ($CaSO_4$). Since the products of gypsum formation occupy much larger volumes than the materials consumed, this process is expansive. As a result, fills containing significant amounts of framboidal pyrite, in combination with calcium carbonate, can cause substantial movements of supported or embedded

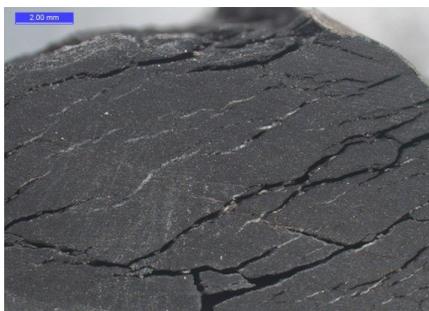
FIGURE 4. A SHALE PARTICLE HAS EXPANDED AT AND NEAR BEDDING PLANES. NOTE THE SECONDARY WHITE CRYSTAL (GYPSUM) GROWTH WITHIN THE EXPANDED BEDDING PLANES.

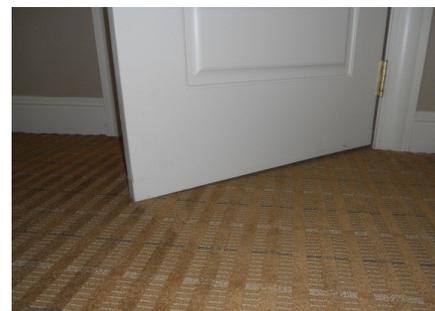
FIGURE 5. A HEAVED FLOOR SLAB HAS RESULTED IN A DOOR THAT CANNOT FULLY OPEN.

Symptoms of slab heaving (often mistaken for settlement) include sloping walking surfaces; cracks and offsets in slabs; cracked, buckled, and crushed drywall; binding doors; and separating or crushed millwork. Effectively managing the symptoms (e.g., grinding slabs, adjusting and under-cutting doors, repairing finishes) is almost always an iterative and disruptive process that ultimately accumulates significant effort and costs. Addressing the cause to prevent future heave requires a one-time project to demolish and reconstruct the slab-on-grade (which, by proximity, necessitates the removal and

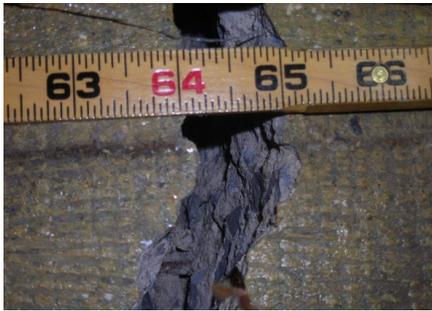
FIGURE 6. A ONE INCH-WIDE CRACK WITH A THREE-QUARTER-INCH VERTICAL OFFSET WAS DOCUMENTED IN A CONCRETE FLOOR SLAB OVER PYRITIC SHALE FILL. PORTIONS OF THE SLAB HAD HEAVED UPWARD MORE THAN TWO INCHES OVER THREE YEARS BEFORE THE SLAB AND UNDERLYING FILL WERE REMOVED.

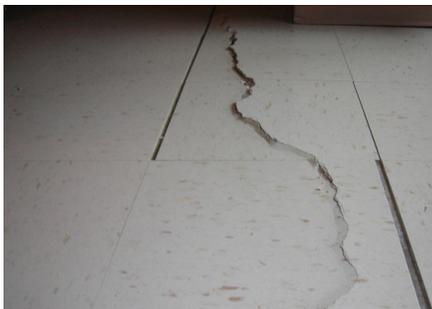
FIGURE 7. A FLOOR SLAB OVER PYRITIC SHALE FILL AND DOWELED INTO A PERIMETER GRADE BEAM EXHIBITED A LARGE CRACK WITH VERTICAL OFFSET AND ROTATION ABOUT THE DOWEL POINT INTO THE GRADE BEAM.
