BY ROSS J. SMITH, PE,
LEED AP BD+C, CDT
Wiss, Janney, Elstner Associates, Inc.

“The Window is Leaking!” 5 Steps to Diagnosing Water Infiltration into Your Building

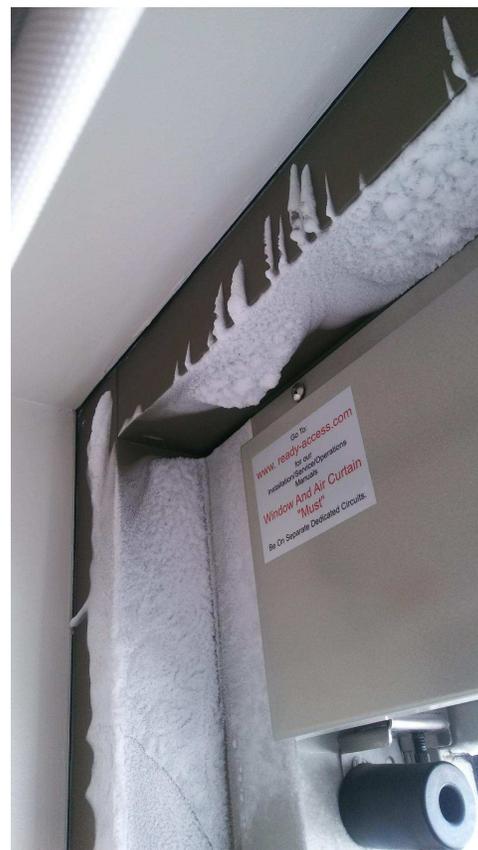
Severe frost/ice development on cold window frames due to condensation and thermal bridging issues (not a leak!)

A winter only condition could be indicative of snow on a sill, or an interior relative humidity/condensation problem (see item 5). If the situation isn't an emergency, in addition to asking good questions, consider tracking the incident(s) with written leak logs/reports including notes and photos describing the situational conditions. Over time, the accumulated documentation may provide detail and better data to evaluate the problem.

there are no vertical jamb streaks, but water pools on one or more horizontal mullion surfaces, it may be indicative of a breach in the exterior gaskets/glazing on the glass lites above the surface(s) in question. Water droplets on all of the frame surfaces likely suggests a condensation problem, which may not be an actual leak at all.

Improper design and or mismanagement of the building heating, ventilation and air conditioning system (HVAC) can lead to problems related to the actual placement of supply and return vents as well as issues with sustained interior relative humidity. These complications can lead to systemic or isolated condensation situations which are often misidentified as a leaks. In northern climates, supplying warm air directly on the windows is a critical feature used to assist in warming the window frames. Directly reducing the amount of moisture in the air further limits the possibility of condensation on cooled surfaces. While there may be an insulation, vapor barrier, or window system positioning problem as well, adjusting pressure to net positive and reducing relative humidity can make a marked difference and may solve your "leak".

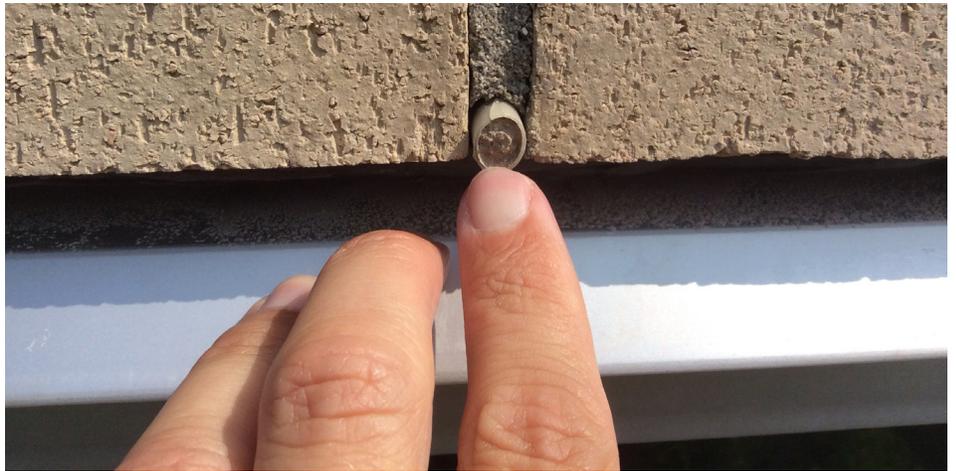
Small plastic weep tube in masonry wall assembly above a window opening

a. Weep/drainage avenues—Windows and curtainwall systems often have a designed drainage pathway fortified by internal glazing seals, and culminating in a

purposeful opening called a “weep”. To an unsuspecting observer, such holes can be misinterpreted as potential leak sources. Enter the frustrated owner, the rogue maintenance person, or the overpromising contractor, armed with the quintessential solution for any and all water problems: the large tube of caulk. Resist the urge to solve everything with caulk/sealant and recognize that misapplied sealant can be the **cause** for infiltration problems. Weep avenues are critical and must remain open. Re-opening an improperly blocked or covered weep (or many weeps), may be your entire leak solution.

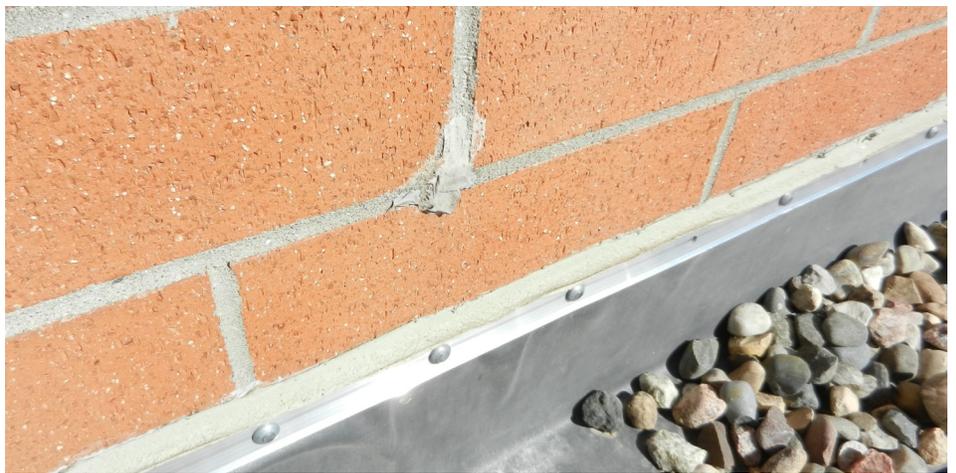
Sealant improperly applied over plastic weep tube in brick masonry wall

If interior leak evidence is found only at the bottom of the window, look more closely at the sill flashing and the weep holes on the exterior (see Items 1a and 4). Clogged weeps and/or failures in the sill flashing may be allowing water to bypass the drainage system and enter the building. If water seems to be on the vertical window elements only, water may be infiltrating into the head of the window from the facade above due to poorly installed flashing or lack of flashing all together. After bypassing the head flashing, water often pools on top of the window frame, seeps through interior frame joints, and streaks down the vertical jambs. When

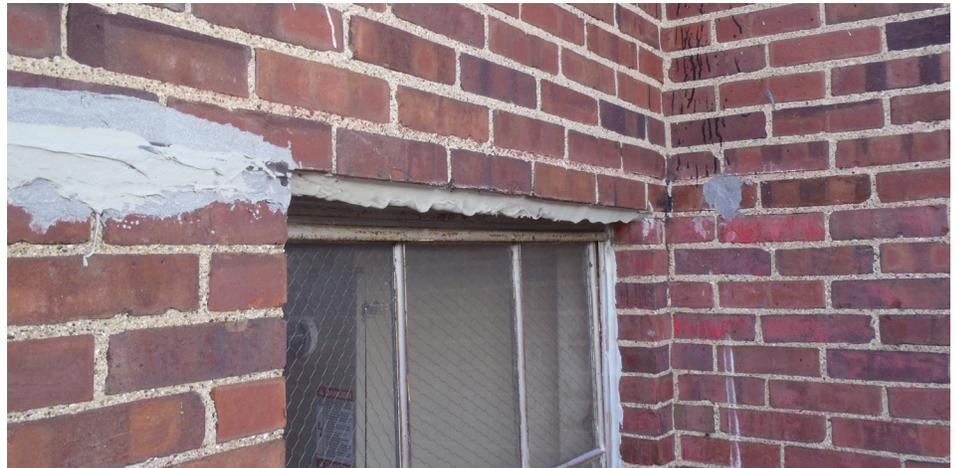
Sealant improperly applied over flashing at the lintel spanning over a window opening

b. Flashings—Like weep accessories, flashing materials can be critical for proper performance of a window drainage system. Flashing materials are typically metal, or membrane, and should be layered in an overlapping shingle-like fashion to allow water to flow down and out. When maintenance occurs around flashings, take care not to cut, damage, or displace the flashings. All too often flashings are sealed where they shouldn't be, trapping water within the wall or window system, eventually forcing it inside, and again, becoming the **cause** of infiltration.
