BY LOGAN COOK

*Wiss, Janney, Elstner Associates, Inc.*

## Addressing Your Building’s Winter Blahs

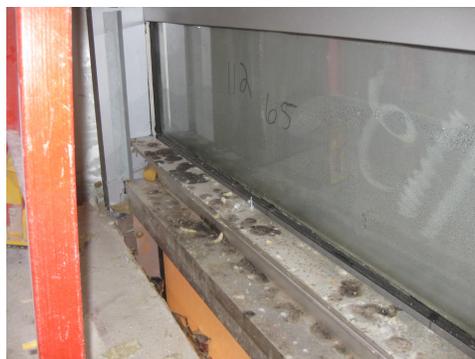
FIGURE 1

Under any weather condition, water vapor in the air travels from warm, humid air to cold, dry air. As exterior temperatures drop and the building heating system begins operating, building envelopes begin to experience changes in air and vapor movement. The warm humid inside air drives toward the colder, dryer exterior. If the warm humid air contacts cold surfaces, such as un-insulated window panes or thermally bridged frames, condensation can occur. Unaddressed condensation can result in water-related damage to interior finishes and, in extreme cases, organic growth. There are many tools available to properly diagnose the factors

leading to condensation issues (e.g., infrared thermography, thermal analysis, and temperature and humidity monitoring). Proper diagnosis of these factors help determine the level of effort recommended for addressing condensation issues, which can range from simple adjustments to interior conditioning parameters up to intrusive system retrofits. See Figure 1.

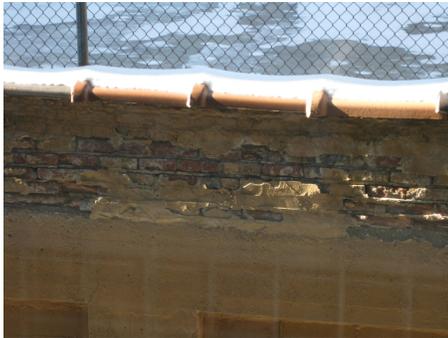
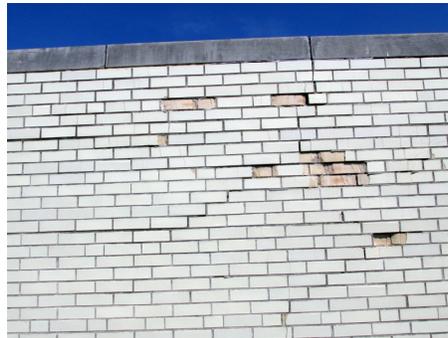
FIGURE 2

Cyclic freezing and thawing is a commonly encountered mechanism of deterioration for exposed building materials such as masonry

or concrete. When water absorbed in materials is exposed to freezing temperatures, the water freezes and expands. During warming periods the water thaws and mobilizes. Repeated cycles of freezing and thawing of the water in the materials can result in deterioration (e.g., spalling and cracking) that can affect aesthetics, material strength, and structural stability. In many cases, freeze-thaw deterioration is related to ineffective or failed water management components or systems. Solutions to freeze-thaw deterioration should look beyond the resulting effects of deteriorated materials and focus on the wall or roof system in its entirety. See Figures 2–3.
