Retrofitting with High-Performance, Aluminum-Framed Window Systems

By Jean J. Wu

“Retrofitting with High-Performance, Aluminum-Framed Window Systems” authored by Jean J. Wu, was published in the August 2016 issue of the *Journal of the National Institute of Building Sciences* (JNIBS), a publication of the Washington, D.C.-based National Institute of Building Sciences. The article has been reproduced here with permission from the publisher. Learn more about JNIBS at <http://www.nibs.org/?page=journals>, and access your free issue(s) by subscribing at http://www.wbdg.org/account/subscribe_inibs.php.

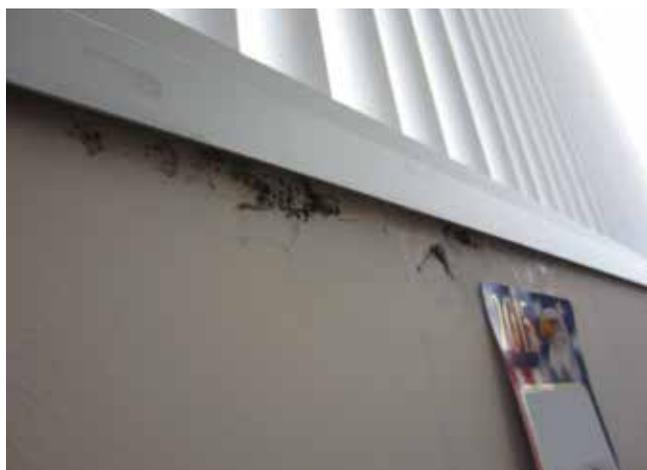
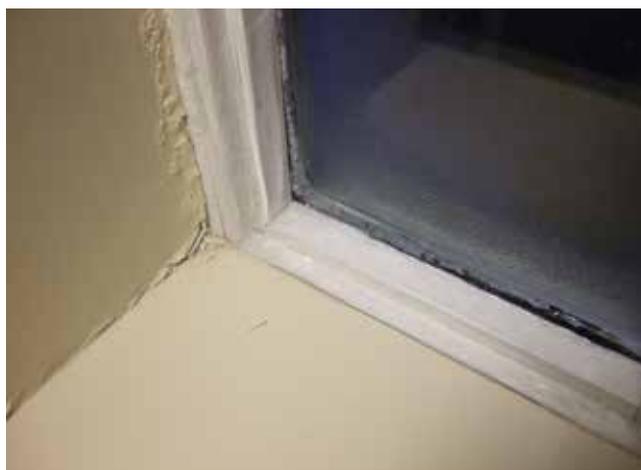
Typical thermal problems with existing window and wall systems include condensation and mold growth on interior finishes (left), as well as ice buildup on window frames and glass (right).

Most of the common thermal problems in existing windows range from air leakage and condensation to occupant comfort and mold development.

Correcting condensation problems can be costly in terms of monetary value and occupancy disruption, which is why proper window perimeter detailing is extremely important.
