Cross-Linked PEX Plumbing Pipes

Evaluation and Materials Testing of Oxidative Failure | AL

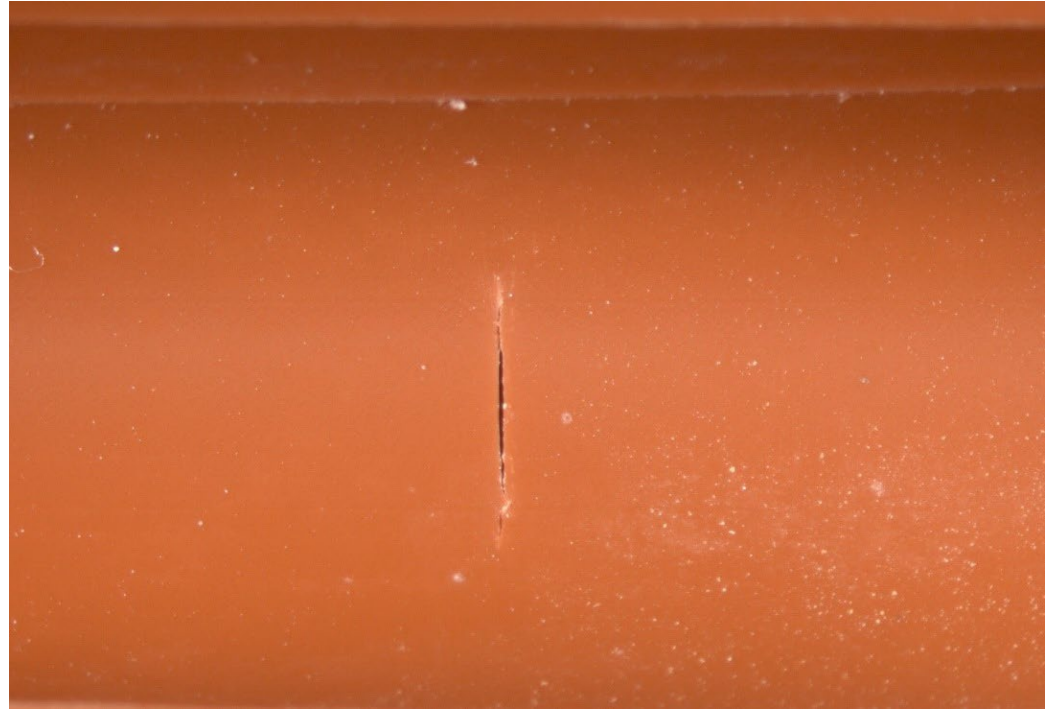
The failed pipes in question exhibited through-thickness perforations, which were consistent with the observed leaks in the system.

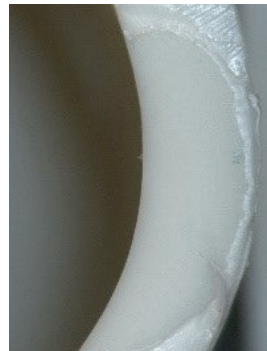
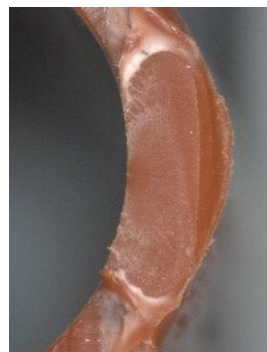
WJE conducted laboratory investigations to determine the cause of leaks reported in PEX potable water-carrying pipes. Our studies confirmed that the observed cracks were the result of oxidative degradation of the PEX material, which directly led to the leaks. This oxidative degradation was caused by the depletion of antioxidants, leading to a severe reduction in the pipes' oxidative resistance by more than 90%.

- Microscopical examination revealed that through-thickness cracks initiated on the interior wall of the pipes, which indicated that the failure was not due to external damage during installation or handling.

- Chemical imaging using the micro-ATR FTIR technique enabled the visualization of oxidation progression, mapping it from the crack origin through the pipe's thickness. This method employed a chemical marker identified by FTIR spectroscopy, reinforcing the findings from both microscopical examination and OIT testing.
