# Cross-Linked PEX Plumbing Pipes

Evaluation and Materials Testing of Oxidative Failure | AL

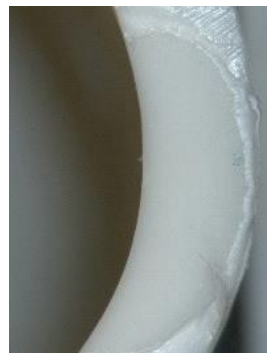
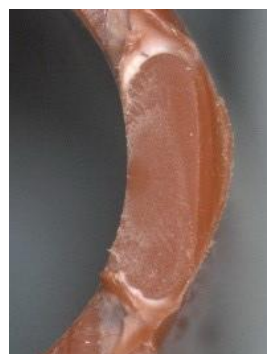
The failed pipes at issue in this project had markings indicating that they were DURAPEX 1006 products and exhibited through-thickness perforations consistent with the observed leaks.

WJE conducted laboratory studies to investigate the cause of the leaks reported in PEX potable water carrying pipes. WJE's studies confirmed that the observed cracks that formed due to oxidative degradation of PEX pipes were the cause of the leaks. The study also indicated that the oxidative degradation was caused by the depletion of the antioxidants, leading to a severe reduction of oxidative resistance (>90%).

- Microscopical examination showed that the through-thickness cracks had initiated on the interior wall. The presence of crack initiation points on the interior of the pipes indicated that failure was not the result of damage due to installation or handling.

- FTIR spectroscopy results showed that the tested samples exhibited oxidation of the polyethylene polymer, especially on the inner wall of the pipes.
- Oxidative Induction Time (OIT) by differential scanning calorimetry (DSC) is an indicator of the effectiveness of antioxidants added to the polymers. The testing results indicate that antioxidant concentrations were very low causing little to no oxidative resistance.
