PROJECT PROFILE

Higbee Building

Facility Condition Assessment | Cleveland, OH

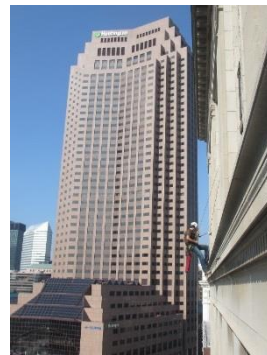
WJE performed a visual condition assessment of the cladding and window systems from the ground using binoculars and from adjacent buildings or roof setbacks. Close range assessment of the facade was performed at select locations by means of industrial rope access techniques. Interior spaces were also examined for evidence of water infiltration or deteriorated conditions.
