John Marshall Hotel

Limestone and Terra Cotta Repairs as Part of Adaptive Reuse | Richmond, VA

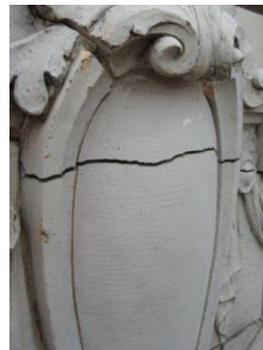
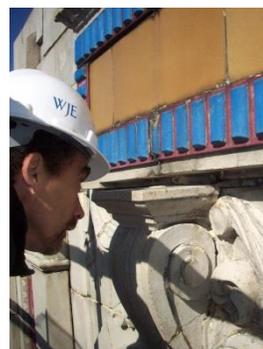
In 2008, plans to convert the space into apartments were temporarily derailed when two limestone cladding panels fell from above the main entrance onto the sidewalk below. Another engineering firm was initially engaged to replace the failed panels and to stabilize and develop repairs for the other panels, but it became clear that the repair design was going to significantly impact the interior of the building as well as the overall project cost. The project team came to WJE in hopes of developing a more cost-effective and schedule-friendly approach.

Through WJE's inspection of the failed area, it was determined that the panel failures were a result of the accumulated load of the limestone cladding combined with accumulation (and confinement) of corrosion scale, which caused the panels to displace outward until the bearing stresses at the kerfs were high enough to fail the stone panels.

The originally proposed limestone panel repair design posed scheduling challenges within a tight construction timeline and failed to meet historic tax credit criteria. Rather than installing bolts through the limestone and terra cotta back-up and into steel framing at the interior, the final repair approach reintegrated the limestone and the terra cotta back-up from only the exterior, using adhesive anchors to secure the limestone to the terra cotta back-up, which maintained the original load path and minimized the need for supplemental strengthening of systems that were not originally designed to carry limestone cladding loads. Through-face adhesive anchors were designed based on test data and load analysis and were used at virtually all limestone panel configurations due to the potential that the existing anchors were corroded and no longer functioning. Every limestone panel was stabilized from the exterior with no need to perform work at the interior, allowing the interior restoration efforts to go forward unimpeded. Additional repairs included full restoration of the polychromatic terra cotta and replacement of unstable brick masonry.
