PROJECT PROFILE

Northwestern University Norris Aquatic Center

Renovation of Swimming Pool and Pool Deck | Evanston, IL

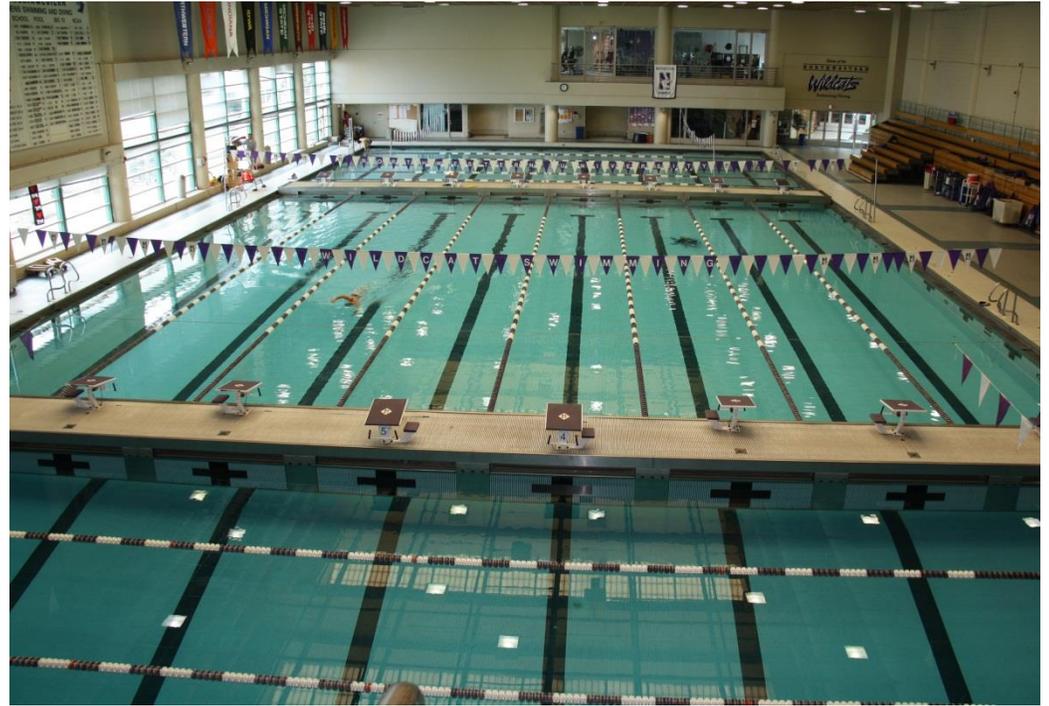
The Norris Center Olympic-size pool, with high dive towers on one end of the pool, consists of cast-in-place concrete foundations and walls and an at-ground level, cast-in-place concrete pool deck slab. The pool deck concrete is finished with ceramic tiles placed in mortar bedding over the waterproofing membrane; pool concrete walls and slabs are also finished with ceramic tiles set in mortar bed. Linear floor drains are set in the perimeter of the pool deck. Three underwater window openings are located in the pool walls. The structure's walls consist of steel columns covered with precast concrete panels and insulated precast wall panels on the exterior along the west, north and east elevations.

The tiles, setting bed mortar, and waterproofing membrane on the pool deck had begun to deteriorate. Linear drains at the pool deck were clogged and needed to be replaced. Tiles and setting bed in the pool were also deteriorated at numerous locations. Portions of the underside of the pool deck were severely delaminated. The client sought an experienced consultant to inspect the deterioration and to develop repair plans. Complicating the project, all repair work had to be completed in nine weeks.

The tiles, mortar setting bed, and waterproofing membrane were removed to expose the structural deck slab. Repairs were made to delaminated areas found on its top and underside. A new waterproofing membrane, grounding, linear floor drains, and concrete topping were then installed to provide the slope for the finished floor. Delaminated tiled areas on the pool's bottom and walls were repaired with new tiles set in mortar bedding. The three underwater windows, existing lights, and speakers were removed. Their cavities were then enclosed with cast-in-place concrete and tiled.
