## PROJECT PROFILE

# Reach Resort

Structural Assessment and Repair Design | Key West, FL

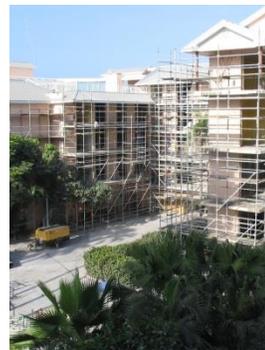
The post-tensioned concrete parking garage for a hotel in Key West, Florida, was experiencing significant concrete deterioration and corrosion of the embedded post-tensioned tendons in the floor slabs. The owners needed an assessment of conditions in the garage and in the hotel building, which was similarly constructed, along with recommendations for necessary repairs. Repairs would have to be implemented while the hotel remained in operation. Additionally, the repairs would have to be coordinated with a complete interior renovation of the property.

WJE engineers determined that chloride contamination of the concrete, coupled with environmental exposure conditions, resulted in the observed deterioration. The engineers performed a structural analysis of the affected floor slabs and developed appropriate concrete and post-tensioning repairs and a concrete protection system for review by the owners. WJE was subsequently directed to prepare construction documents outlining the necessary repairs. The repair design accounted for coordination with facility operations and other interior renovation work. During the repairs, WJE provided construction administration services, including full-time construction observation as requested by the owners. Specific repairs included the following:

- Removal and replacement of deteriorated concrete, including slab edges, shear walls, girders, and slab soffits
- Splicing and/or replacement of existing post-tensioned tendons, including installation of new corrosion protection systems
- Application of a urethane membrane to the top surfaces of concrete balcony and walkway slabs
- Application of an acrylic architectural coating to all concrete repair areas, excluding the top surface of the balcony slabs
- Replacement of existing handrails with a new aluminum handrail system
