# St. Clare's Hospital

Condensation Investigation and Repair Design | Weston, WI

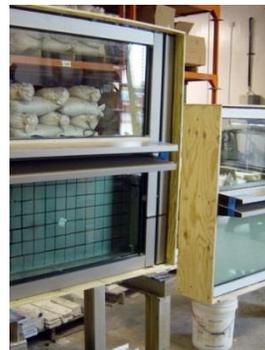
Beginning shortly after original occupancy, the windows displayed wintertime condensation within the shadow box spandrels on the exterior wall. Knowing the facility humidifies the air for patient comfort and equipment safety, WJE observed that the insulation was not 100 percent sealed to the framing, allowing moist air to exfiltrate. This condition created unsightly clouded spandrels and unacceptable water penetration. WJE was retained to perform comprehensive testing and to develop a repair that could be quickly implemented before the next winter.

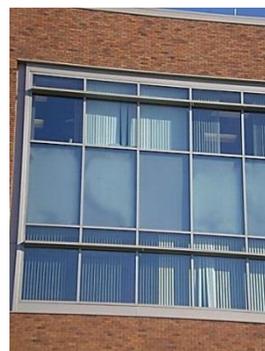
Several four-square-foot mock-ups of different shadow box spandrels identical to the hospital's windows were made by the original project window contractor for WJE. WJE developed several repair techniques and tested the spandrels in an environmental chamber capable of creating extreme wintertime temperatures on the outside as well as the interior temperature and humidity conditions of the hospital. The mock-ups were instrumented to measure surface temperatures, and a view panel was installed to observe condensation within the shadow box spandrel. Based on results from the testing, WJE met with the hospital and design/construction team and proposed repair options for their consideration.

Repairs were implemented by the original contractor over a four-month period. All repairs, including removal and reinstallation of the existing glass, were completed from the exterior of the building to avoid disruption to hospital operations. WJE made periodic visits to the hospital to observe that the installation was in accordance with the repair designs and offered recommendations to keep the project on time and help assure a successful outcome.
