PROJECT PROFILE

University Parking Garage

Structural Analysis and Steel Repairs | New Haven, CT

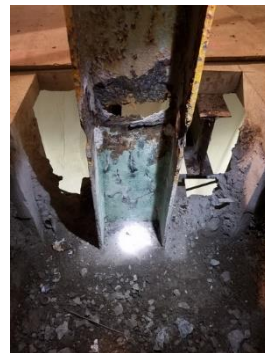
This parking garage had several chronic problems that could not be solved by several previous engineering firms engaged by the Owner throughout the life of the structure. The garage was leaning several inches. The columns' webs were buckling where pinched by the girder moment connections, and long-term water infiltration and exposure to deicing salts caused severe corrosion of the steel frame. The Owner thought the garage needed to be torn down, but engaged WJE to determine a way to extend the life of the garage and maintain vital parking capacity.

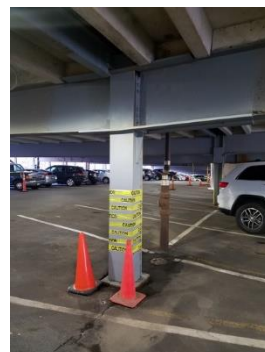
The structure was modeled in CSI SAP2000 and a detailed finite element analysis using Autodesk Simulation Mechanical. The finite element model of a typical moment connection served to locate points of high stress in the connection, particularly at the bolts and welds. In combination with the finite element model, the SAP model provided a better understanding of the behavior of the gravity system and the utilization ratios of the columns.

Columns with critical utilization ratios and severe section loss were selected to receive specialized repairs. Our repair design permitted direct transfer of concentrated girder flange forces without further pinching the columns. Our repair design also restored the cross-section of the heavily corroded columns. Braced frames were added to resist the lateral earth pressures imposed by the improperly designed retaining walls. Repairs were designed to minimize disruption to parking capacity. Our collaboration with the steel fabricator enabled just-in-time design and manufacturing of the shoring, as well as the permanent repairs to achieve the client's goals.
