PROJECT PROFILE

Bridge and Highway Barriers

Calcined Dolomite Contamination of Concrete | United Kingdom

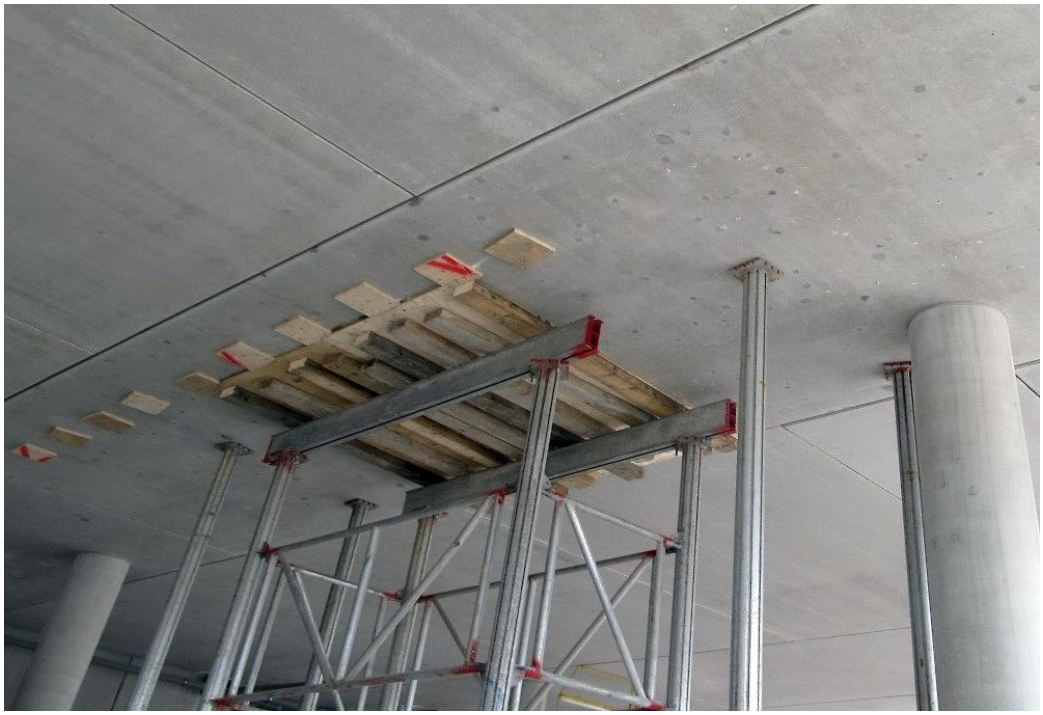
Coarse aggregate used in the manufacturing of precast and cast-in-place concrete was contaminated with calcined (dead-burned) dolomite. The contamination of the aggregates was not discovered at the source, leading to the manufacturing of precast and other concrete products containing the deleterious dolomite particles. Shortly after installation the affected products began to exhibit progressive surface popouts. The popouts were typically no greater than 10 mm deep and 50 mm in diameter, and their frequency relative to the products surface area was found to be generally small.
