## RESTORING THE MONUMENT

# Monumental

By **Daniel J. Lemieux, AIA, R.A., M.ASCE,**  
and **Terrence F. Paret, M.ASCE**

# Challenge

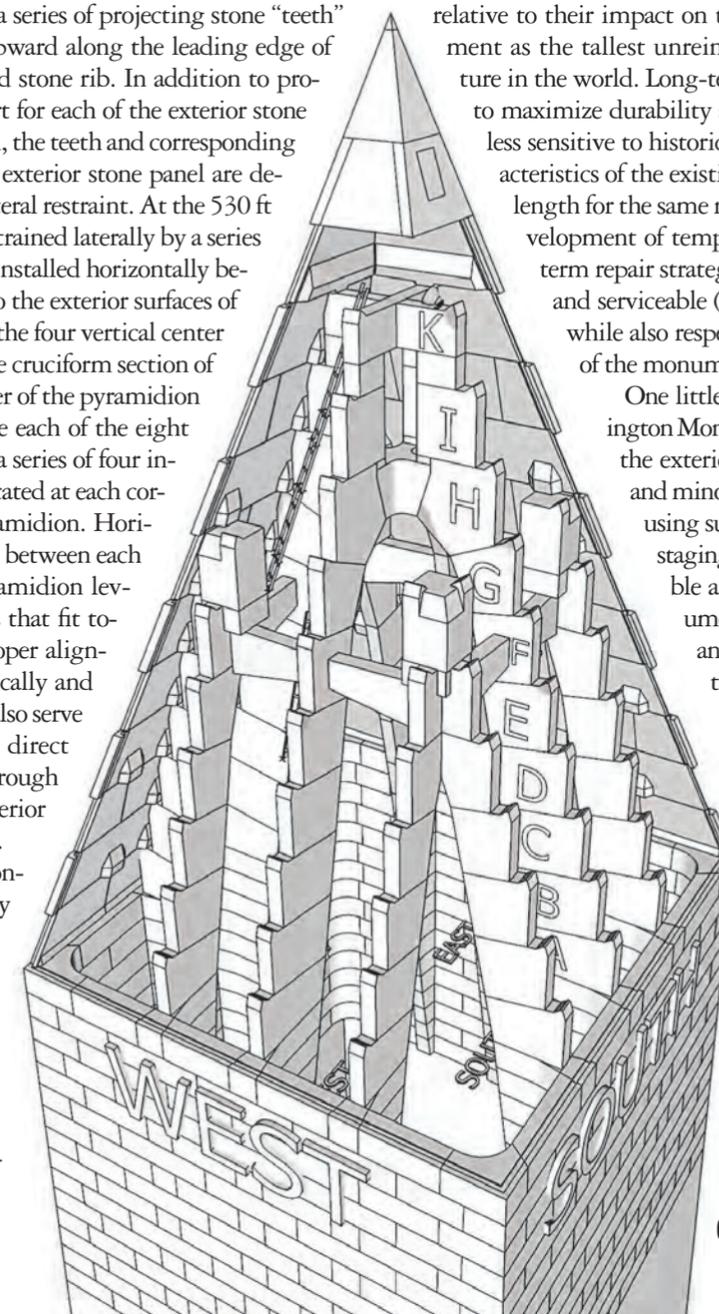
**Cracking is visible on a marble panel unit at course G on the west elevation of the pyramidion (stone W. 529.2).**

Red arrows indicate a crack at course G on the west elevation of the pyramidion (stone W. 529.2); green arrows indicate the knuckles; the blue arrow indicates the rib. The illustration below indicates the interior construction of the pyramidion as viewed from the west face.
