PROJECT PROFILE

# Cable-Stayed Roof Structure

Structural Cable Inspection | Midwest

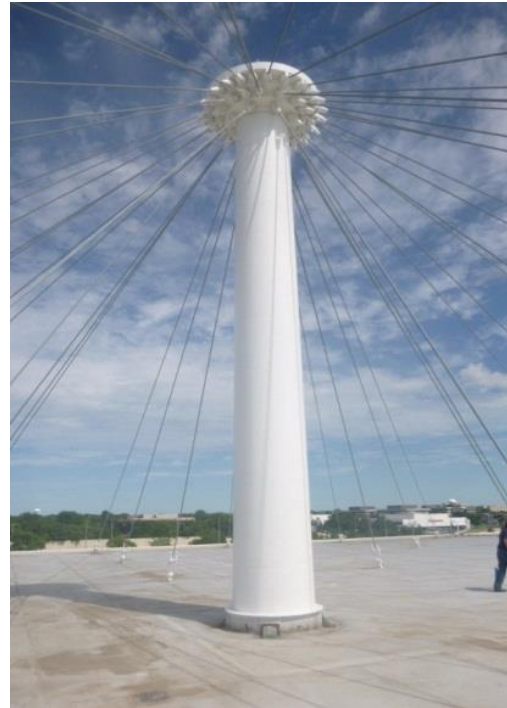
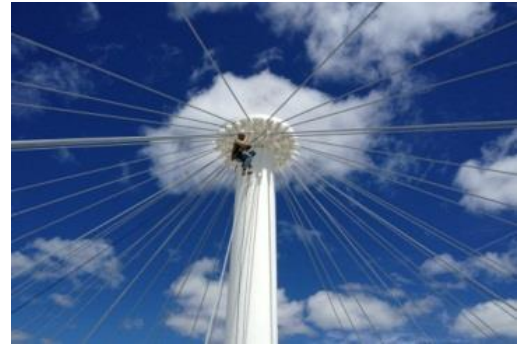
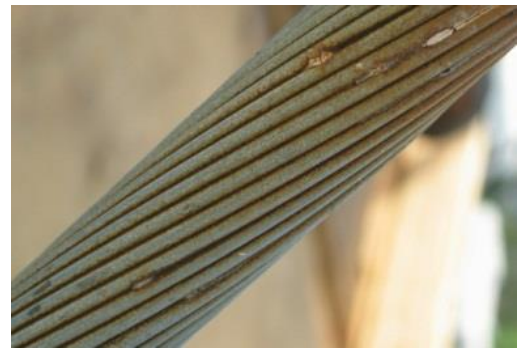
Each suspender cable is composed of many small diameter steel wires that are wound in a helical pattern. During WJE's inspection, some cables were noted to have localized discoloration or light surface corrosion beginning between the individual cable strands. Also, near the upper ends of several cables, water dripping from the top row of clevises onto cables anchored at the two rows below caused areas of the lower cables to experience prolonged exposure to moisture. Accelerated wear of the galvanized coating in localized areas and the onset of corrosion began as a result. Spreading of the individual wires of the cables in these areas was observed at one such location. Abrasion of the galvanized coating along the length of the cables was also observed to have caused moderate surface corrosion in localized areas.

The level of corrosion did not pose a structural concern. However, since these cables serve as the primary structural support for the roof, WJE recommended a more frequent inspection cycle to establish the rate of progression of the corrosion on the cables. To avoid the expense of constructing scaffolding around the cables to facilitate access for inspections, WJE was retained to utilize industrial rope access techniques to access the tops of the masts and to inspect the lengths of the cables and their anchorages. Climbing, rappelling, and ascending were utilized to provide arms-length inspection of the cable anchorages at the tops of the masts as well as at an assortment of cables during each inspection.
