PROJECT PROFILE

# Duke University Chapel

Visual Inspection of the Vaulting System | Durham, NC

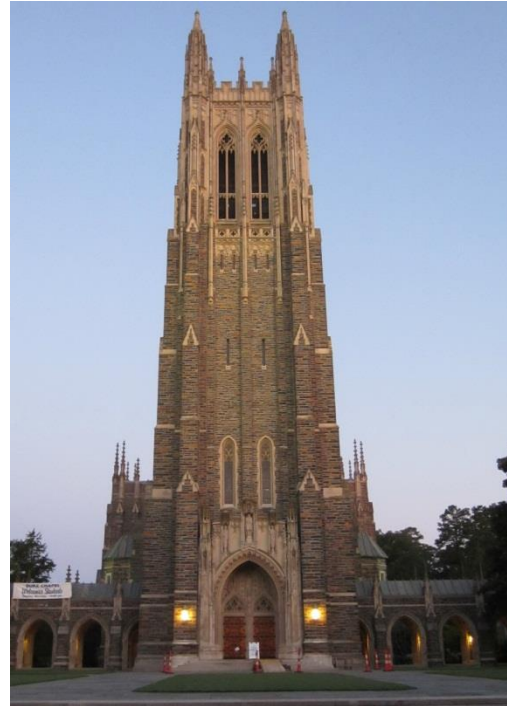
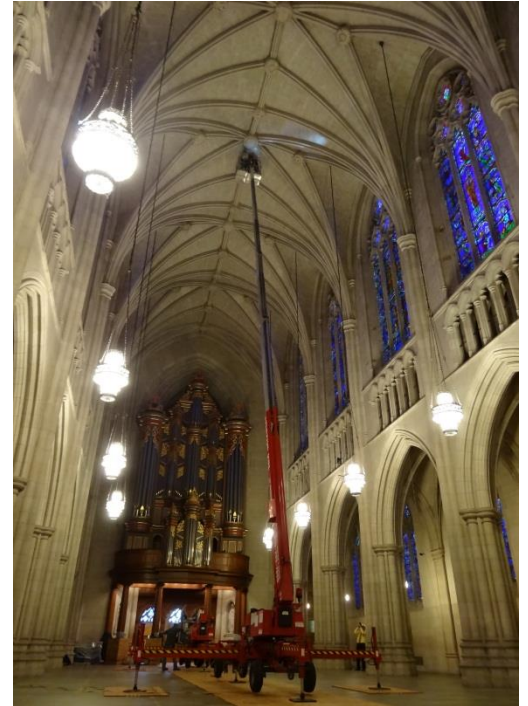
The close-up inspection revealed cracks in several keystones, stone ribs, Akoustolith ceiling tiles, and mortar joints. Separations were noted between the stone ribs and the Akoustolith ceiling, and vertical translation of individual stones in the vaulted ribs was observed in several locations. Cracking and movement of the stone ribs likely occurred over a long period of time, as evidenced by observations of sealer applied in 1973 both inside of and stretched across the existing cracks. At one of the displaced pieces, spalled white mortar indicated recent movement, and the cracking pattern suggested upward movement of the crown and lateral movement of the lower portions of the ribs. The cause(s) of these movements were not readily apparent from the results of the close-up inspection; however, the widespread nature of the distress reflected a systemic problem rather than a localized condition. Loose pieces of stone and mortar were removed during the close-up inspection, yet continued movement will likely result in additional loose pieces.

To temporarily stabilize the area until permanent repairs could be made, WJE recommended hanger rods be attached to anchors set into the stone pieces and to steel angles anchored to the concrete roof deck above. Long-term repairs will be determined from additional materials testing and structural analysis.
