PROJECT PROFILE

Kenosha Medical Center Campus

Masonry Distress Investigation and Repair Design | Kenosha, WI

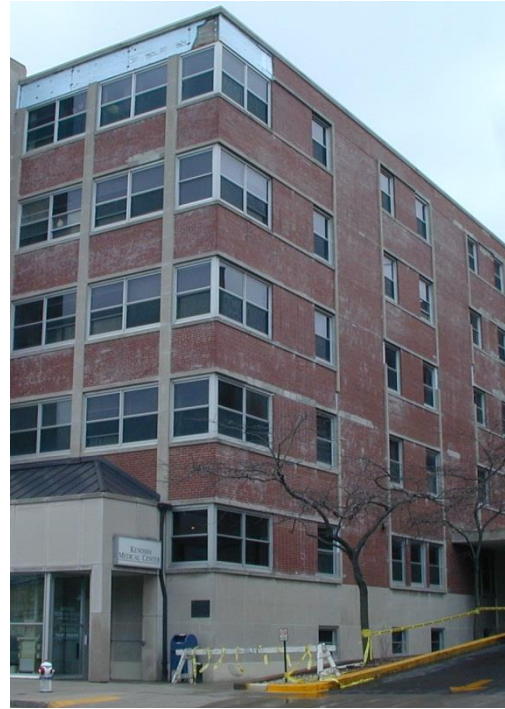
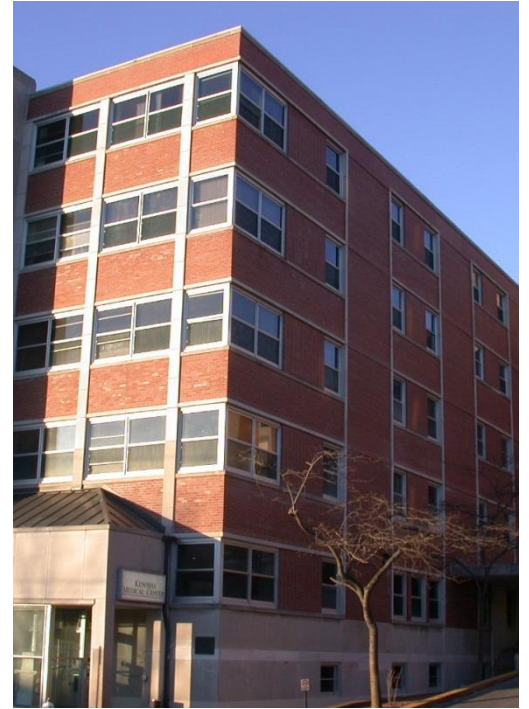
A masonry-clad hospital building experienced problems of moisture penetration, staining of exposed surfaces, outward displacement of masonry, and spalling of limestone trim pieces. The property owner sought to determine the cause of the distress and to implement repairs to restore the exterior walls.

- The mortar contained extremely high levels of chloride ions at concentrations well above the threshold necessary to promote corrosion of embedded steel. The probable source of chlorides in the mortar was the use of calcium chloride as an accelerator during construction in cold weather.
- Advanced corrosion had developed on embedded steel elements in the masonry, including wall ties and shelf angles. Spalling occurred in the masonry as a result of forces generated by this corrosion.
- Poor flashing details allowed water to remain within the walls, compounding the vulnerability of steel to corrosion.

Remedial measures were developed to salvage most of the building's facade components. These included replacement of the embedded steel shelf angles and through-wall masonry flashings, remedial anchoring of the masonry veneer, selective replacement of limestone trim around windows and at other locations where spalling occurred, and tuckpointing of mortar joints to help minimize water penetration.
