Robert D. Moreton Building

Assessment of Distress to Precast Facade Panels | Austin, TX

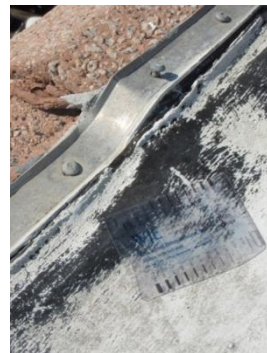
The distressed panels at the Moreton Building are comprised of an architectural concrete mix, with exposed crushed granite aggregate and pink pigment. The wall panel distress included bowing of the precast wall panels, separations in wall finishes adjacent to the exterior walls, and spalling of the panels near joints. WJE was requested to perform an assessment of the panel bowing.

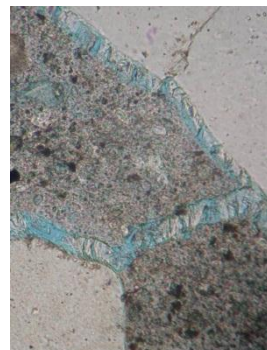
WJE's initial investigation included a visual condition survey and laboratory analysis of core samples taken from the building. Through this assessment, WJE was able to determine that the distress was due to delayed ettringite formation, a type of internal sulfate attack. WJE performed additional laboratory analysis and determined it was highly likely that the distress would continue, to the point that the structural integrity of the panels could be compromised. WJE developed temporary repairs to slow the rate of distress but recommended that the State plan to eventually replace the panels. The State implemented the temporary repairs and has since allocated funds for removal of the panels and replacement of the building envelope. WJE is serving as the exterior envelope consultant on the design team for the recladding project, which is currently in progress.
