St. Paul's Union Depot: Revitalization of a Historic Concrete Train Depot

BY ARNE JOHNSON, JONAH KURTH AND KEVIN MICHOLS

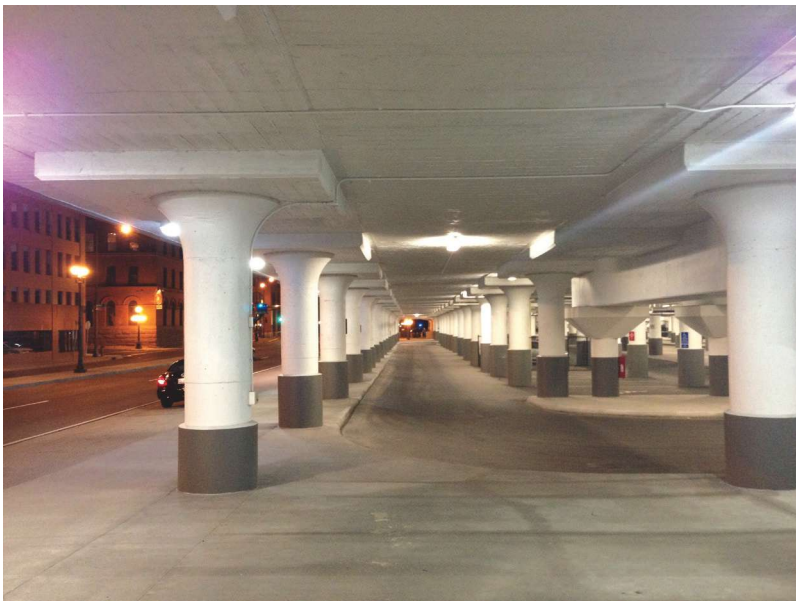
Fig. 8: Rehabilitated Depot structure

Rehabilitation of the historic railroad terminal hinged on whether the 90-year-old structure with widespread and locally severe deterioration had

sufficient remaining capacity, or if the structure could be effectively and practically repaired to support the anticipated loads of the rehabilitated facility. The unique engineering approach used to assess the concrete superstructure and timber pile foundations of this very large facility was sufficiently thorough while still being cost-effective and efficient. Comprehensive inspections followed by targeted testing showed the extent and causes of deterioration, allowed the development of repairs to address the underlying deterioration mechanisms, and provided a means of accurately estimating concrete repair quantities. The resulting information substantiated the ability for most of the original structure to be retained and effectively repaired for the desired 50-year service life. The extensive rehabilitation was completed in just 23 months and the revitalized Depot opened in December 2012 (Fig. 8 and 9). A walk-through of the structure in 2018 confirmed overall good performance of the concrete repairs to the track deck, with no new signs of structural settlement or unexpected deterioration. ■

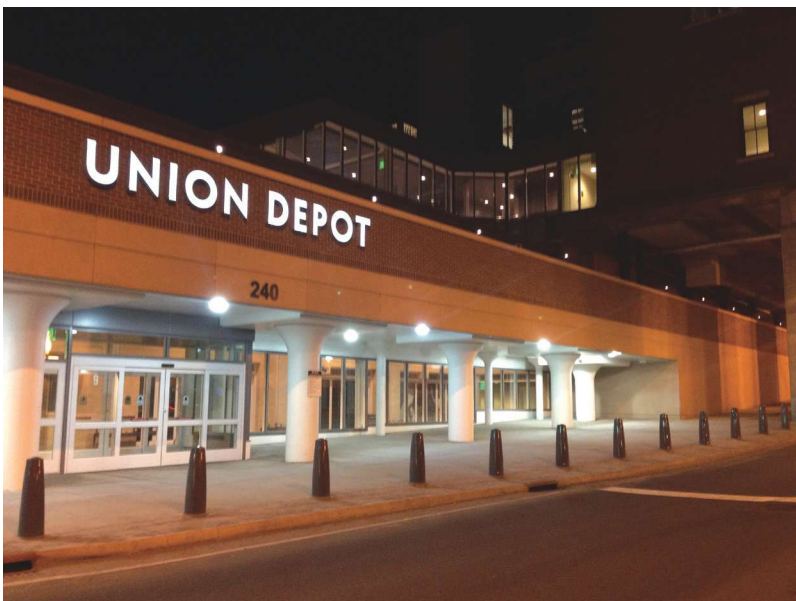
Fig. 9: Rehabilitated Depot entrance
