PROJECT PROFILE

Cable-Stayed Roof Structure

Structural Cable Inspection | Midwest

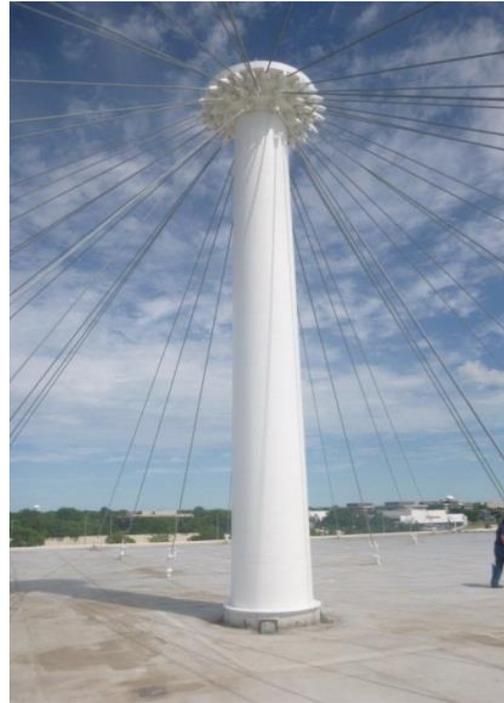
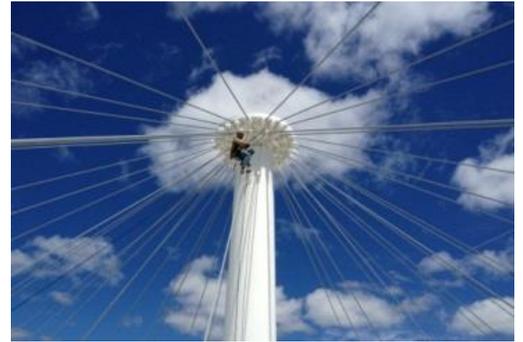
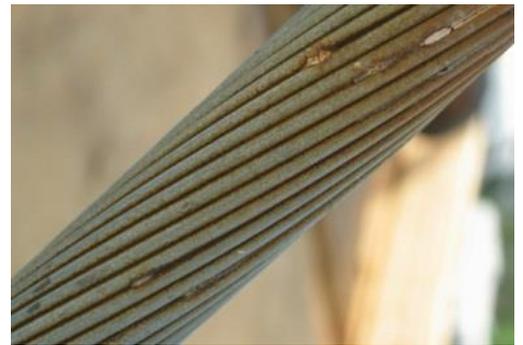
Each suspender cable is composed of many small diameter steel wires that are wound in a helical pattern. During WJE's inspection, some cables were noted to have localized discoloration or light surface corrosion beginning between the individual cable strands. Also, near the upper ends of several cables, water dripping from the top row of clevises onto cables anchored at the two rows below caused areas of the lower cables to experience prolonged exposure to moisture. Accelerated wear of the galvanized coating in localized areas and the onset of corrosion began as a result. Spreading of the individual wires of the cables in these areas was observed at one such location. Abrasion of the galvanized coating along the length of the cables was also observed to have caused moderate surface corrosion in localized areas.

The level of corrosion did not pose a structural concern. However, since these cables serve as the primary structural support for the roof, WJE recommended a more frequent inspection cycle to establish the rate of progression of the corrosion on the cables. To avoid the expense of constructing scaffolding around the cables to facilitate access for inspections, WJE was retained to utilize industrial rope access techniques to access the tops of the masts and to inspect the lengths of the cables and their anchorages. Climbing, rappelling, and ascending were utilized to provide arms-length inspection of the cable anchorages at the tops of the masts as well as at an assortment of cables during each inspection.
