PROJECT PROFILE

Trimont Condominiums

Facade Condition Assessment | Pittsburgh, PA

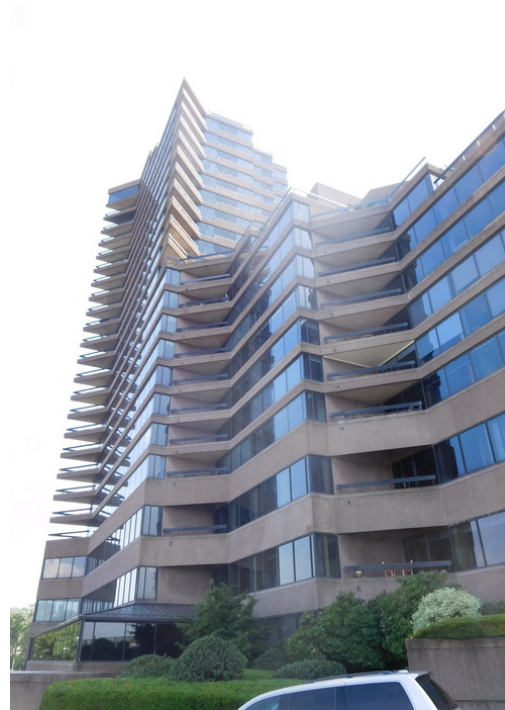
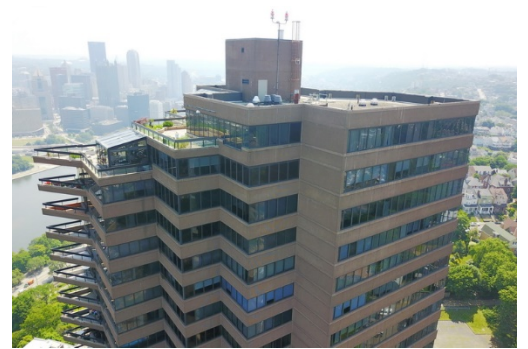
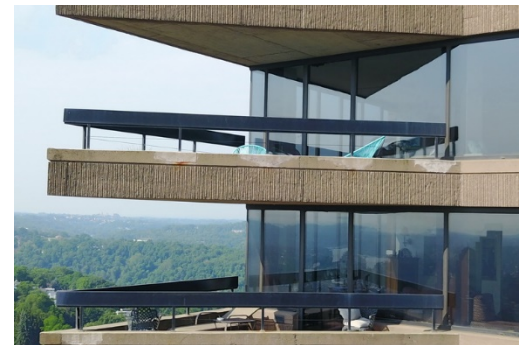
Concrete spalls throughout the facade appeared to be directly related to corrosion of the embedded reinforcement. The incipient spalls observed at many locations presented a risk of falling debris to pedestrian and roof areas below. Field observations of reinforcement cover dimensions revealed that reinforcement bars were located near the exterior surface of the concrete in numerous locations. The corrosion of the embedded steel reinforcement did not appear to be caused by chloride admixtures within the concrete, but rather by carbonation of the concrete from natural atmospheric exposure of the building.

Recommendations were provided to conduct a more detailed examination in preparation of developing a comprehensive repair program.
