PROJECT PROFILE

Zionsville Fire Department Station 93

Roof Assessment | Zionsville, IN

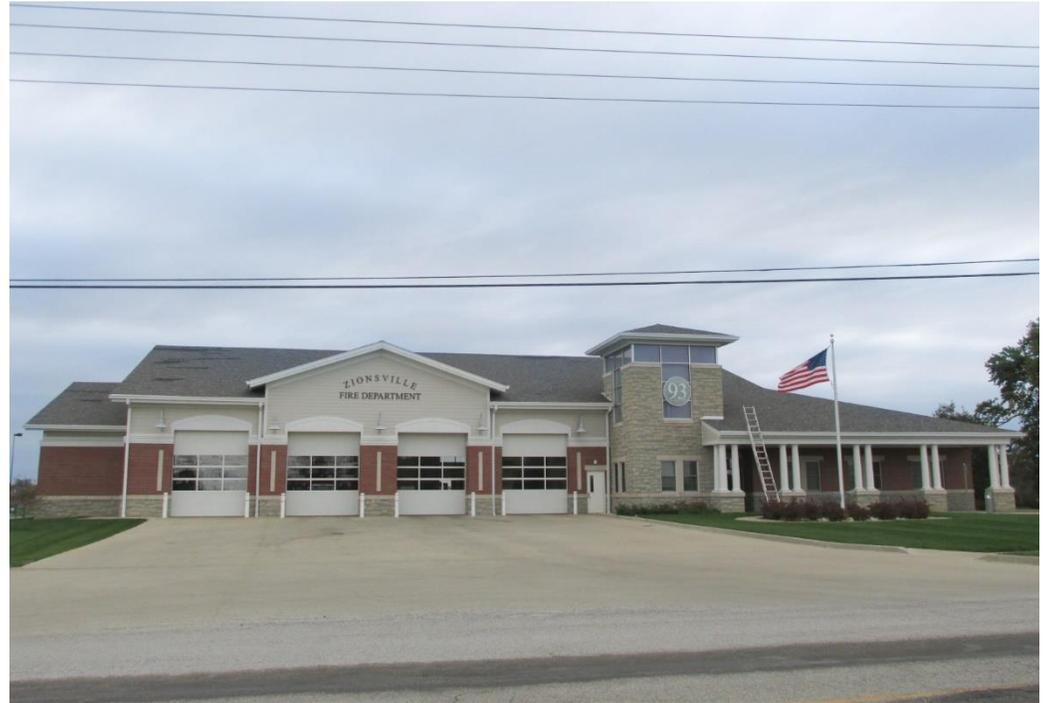
After construction of the Zionsville Fire Department Station 93, the roofing shingles began to blow off the roof as a result of moderate wind speeds. The Zionsville Fire Department engaged WJE to investigate the cause and provide recommendations for repair.

Based on WJE's observations and review of the architect field reports, the damage to the roofing was largely the result of installation-related deficiencies. The architect field reports indicated that the roofing shingles were installed during cold weather in the winter months, and WJE's visual observations confirmed that the shingle edges did not adequately seal to the underlying shingles due to the cold temperatures at installation.

Without repairs, the building would become susceptible to water leakage due to existing damaged areas and further wind-related damage from deficiencies in the existing system. WJE recommended removing and replacing the damaged shingles and installing asphalt roofing sealant at all edges to provide adequate sealing to the underlying shingles.
