PROJECT PROFILE

605 Waterford Garage

Condition Assessment | Plymouth, MN

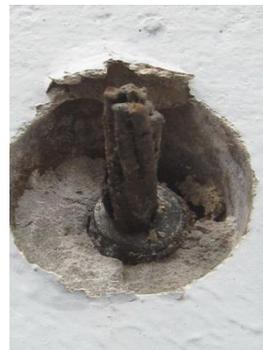
After acquiring the 605 Waterford Parking Garage in 2005, CB Richard Ellis noticed that water leakage was occurring through the upper level deck at expansion joints and the brick pavement area. In addition, two failed post-tensioning tendons were observed. WJE was retained to perform a condition assessment of the garage and to provide general recommendations for the necessary repairs.

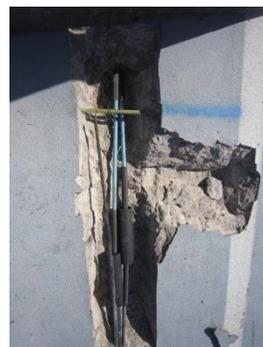
WJE found the parking garage to be in good condition; however, localized structural distress and water leakage problems were present at various locations which warranted repair. The structural distress primarily resulted from water infiltration, and potentially chloride ion ingress, into the concrete and included the two failed tendons. The water leakage primarily resulted from the deterioration and failure of the expansion joints and from defects in the waterproofing installed below the brick pavement turnaround.

To maintain the serviceability of the structure, partial-depth concrete repairs, post-tension tendon repairs, guard rail post and cable repairs were recommended, along with replacement of the waterproofing system. WJE also recommended that a more durable expansion joint seal system be designed and installed during replacement of the existing expansion joints.
