# Architecture Building

Brick Masonry Facade Assessment and Repairs | Lubbock, TX

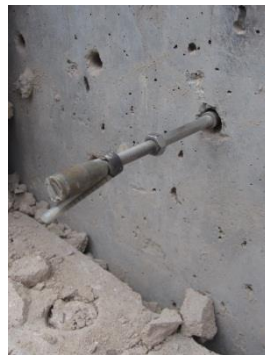
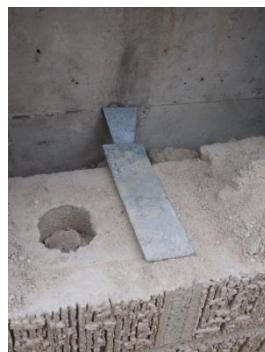
WJE was again contacted in 2002 to evaluate the brick masonry facade and building sealants. Sealants were judged to have failed over the entire building and new evidence of masonry distress was observed. In 2011, WJE was asked to evaluate the facade, and during this site visit, conditions were judged to have deteriorated further. Additional areas of distress were observed, and the brick masonry was observed to be bowing outward between the lintels at many of the twelve stories of the building.

The assessment revealed that both the remedial pins and the shelf angle anchorages were performing well. WJE discovered that the required shelf angle had not been installed continuously at several locations as specified in the construction documents. Additionally, the horizontal expansion joints that were recommended in 1985 were never installed. The additional areas of distress in the brick masonry were locations where the repairs to relieve stress had not been performed in 1985.

WJE determined that the bowing in the brick masonry was caused by the lack of horizontal expansion joints and recommended their installation. Additional horizontal and vertical expansion joints were also recommended to accommodate veneer movement. WJE prepared construction documents for those repairs and is currently working on a project to provide swing stage access to the facade to lower repair costs.
