Jesse H. Jones Hall for the Performing Arts

Roof Investigation and Repair Design
Houston, Texas

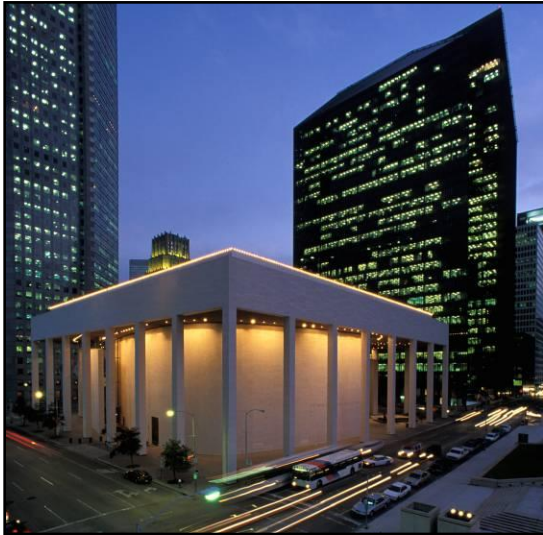
The modified bitumen roof membrane on this performing arts center exhibited severe granule loss and widespread deterioration, including splits, voids, and debonded seams. The owner wished to extend the life of the failing roof system until funds were available for reroofing.

Jones Hall is a three-thousand-seat performing arts center in downtown Houston. Constructed in the mid-1960s, the structure is 120 feet tall. The roof system consists of a mechanically attached base sheet, three plies of roofing felts, and a granulated modified bitumen cap sheet adhered in hot asphalt.
