## Saint Joseph's Church

Structural Investigation of Fire Damage  
Yakima, Washington

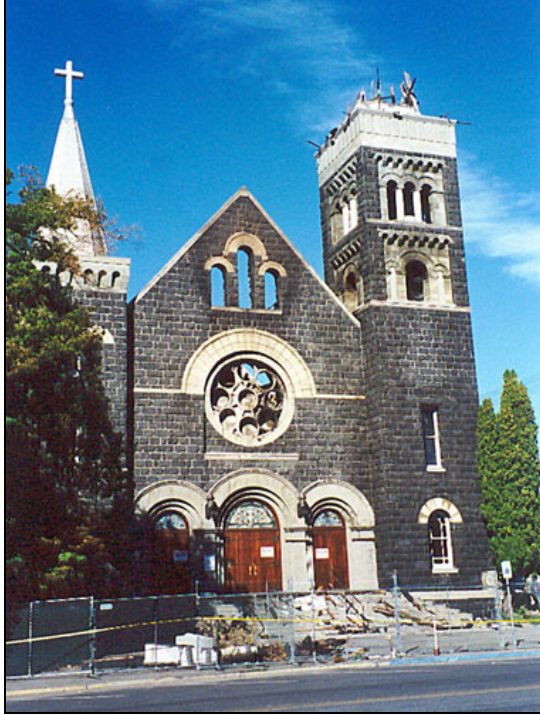
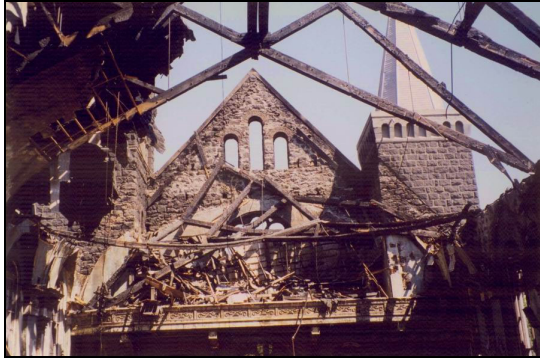
Built in 1905, this historic church is constructed of various materials: the church walls are stone and brick masonry; the bell towers are concrete and masonry; and prior to a fire, the roof was framed with large timber trusses and rafters.

- Concluded that most of the fire had been confined to the timber roof structure and that structural damage to the masonry walls was minimal
- Developed conceptual repairs to restore the fire-damaged masonry and concrete, replace the roof with new framing, and tie the new roof to the existing masonry walls to improve the seismic performance of the structure
- Designed repairs to restore the structure to its original appearance and function
