Tarrant County College Natatorium

Condition Assessment of Double Tees | Fort Worth, TX

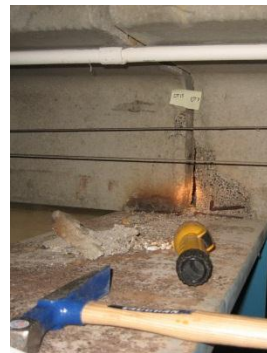
Concrete cracks, spalls, and corrosion stains were identified during a cursory inspection of the roof's underside in connection with planning for an overall renovation of the facility. The roof was located 30 feet above the pool and ground level viewing was obstructed by HVAC and lighting. As a result, the ability to assess the damage was limited. Concern existed regarding the possibility of concrete debris falling into the pool or adjacent deck. A detailed assessment was needed to help the architect and owner evaluate the feasibility of renovating the facility.

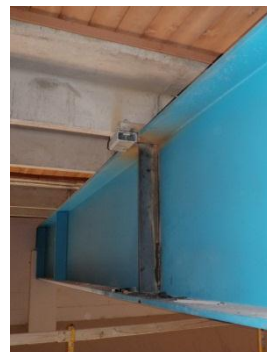
WJE performed a condition assessment to identify the extent, cause, and significance of distress in the roof double tees in the natatorium. One of the most challenging aspects was difficulty in accessing the bearing area of the double tees, where the majority of the distress was located. Scaffolding was installed over the entire footprint of the swimming pool to provide a working platform from which a detailed close-up, hands on inspection could be performed. At three locations, the distress was found to be structurally significant and in need of immediate remedial measures. At other locations the distress was less severe, but still in need of remedial measures to ensure satisfactory long-term structural performance. The majority of the distress was caused by restrained volume change due to welding of the bearing plates. WJE prepared drawings and specifications for remediating the identified damage. The remediation program included steel saddle assemblies, concrete patching, and corrosion inhibiting coatings.
