# Assessment and Repair Considerations with Indiana Limestone

BY TIMOTHY M. CROWE, ALA, SE, PE

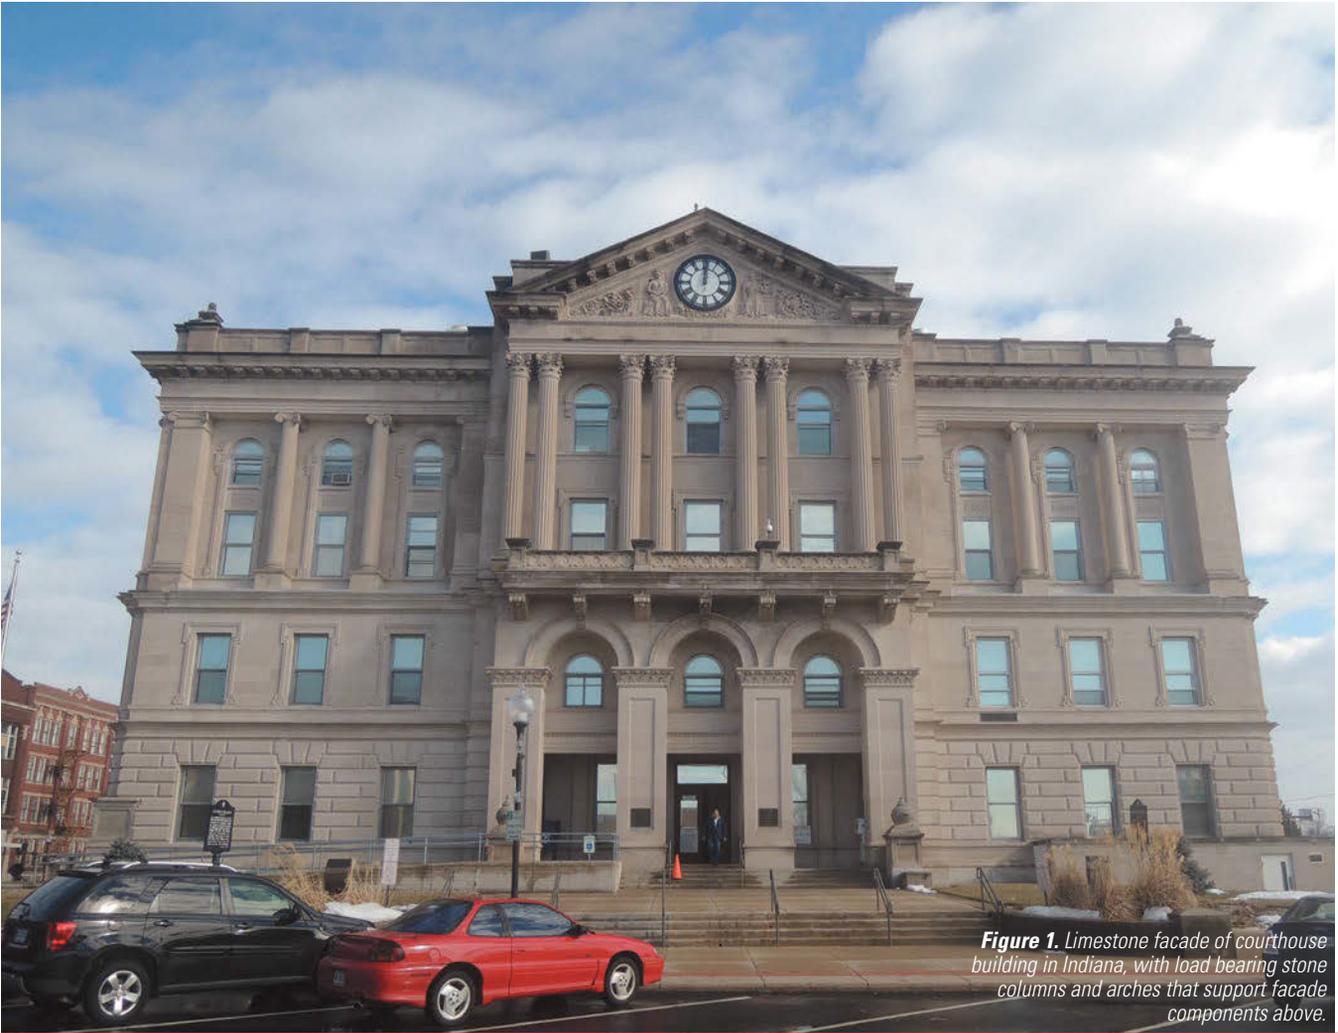
*Figure 1. Limestone facade of courthouse building in Indiana, with load bearing stone columns and arches that support facade components above.*

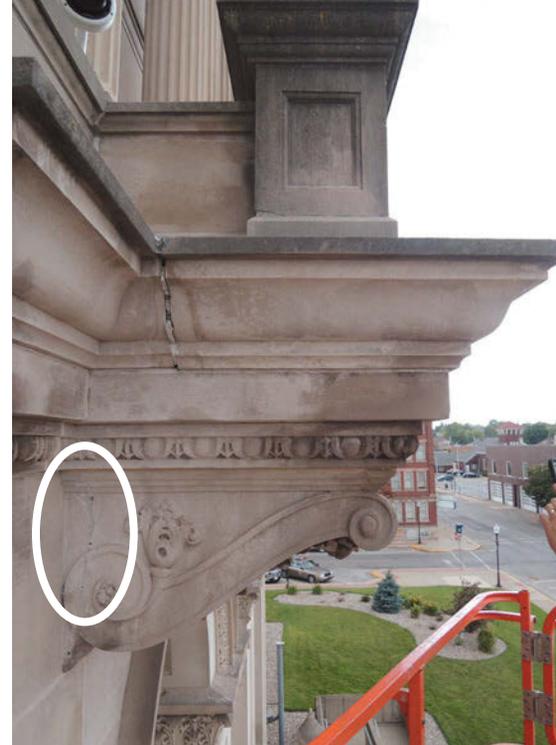
**Figure 2.** Epoxy repair at cracked cantilevered corbel.

Cracks can result from the corrosion of embedded ferrous metal anchors and elements, building settlement, differential movement within adjacent materials, or improper water shedding. Embedded ferrous metal may be remediated with removal of mild steel anchors and installation of non-corrosive anchors (e.g., stainless steel or bronze anchors). Depending upon the unit and size of spalls, stones may then be repaired with dutchmen (partial stone unit replacements) or patched with an appropriate repair mortar. However, as cracking may be attributed to settlement, differential movement, or other concerns, it is necessary to confirm if this movement is still active prior to selecting a repair. Cracks may be addressed with properly detailed sealant or epoxy materials if the stability of the crack is understood. However, if the cause of distress is not understood, repairs may not address underlying issues and can thus provide a false sense of security. An example of this was observed at a courthouse building in Indiana, where stone corbel failures had been reported. A previous corbel repair (Figure 2) utilized epoxy injection along a crack within the stone. Epoxy applications such as this may address water infiltration at this crack, but would have questionable efficacy in strengthening this element and may not be compatible with the adjacent stone because of different material characteristics. This cantilevered stone, which supports a stone balcony, had also been packed with mortar along its full length. The mortar at the corbel projection introduced an unintended load path that could increase stresses in this corbel at the epoxied crack, increasing the risk of corbels falling from the building. A repair approach was developed that removed mortar from portions of this joint, to reduce stresses within the stone and restore the intended load path. In addition, a mechanical connection of the corbel was introduced to further reduce the stresses and demands on the epoxied crack.

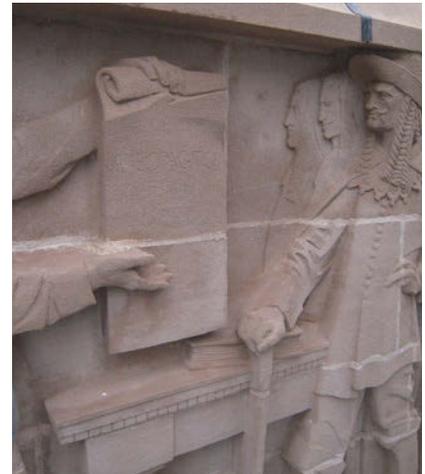
**Figure 3.** Example of stone carving on the Nebraska State Capitol that had been damaged by aggressive abrasive cleaning techniques as part of prior building maintenance. Note that the writing on the tablet is nearly gone.

Additional masonry maintenance concerns, not limited to Indiana limestone, include aggressive cleaning campaigns such as sandblasting or strong chemicals (acids) that can both degrade the stone and damage underlying support systems. In the mid-twentieth century, the unfortunate practice of sandblasting masonry facades as a cleaning practice was common. The end result was usually a loss of carving/detail on the stone (Figure 3), as well as a rougher surface that ironically is more vulnerable to dirt and biological growth accumulation.

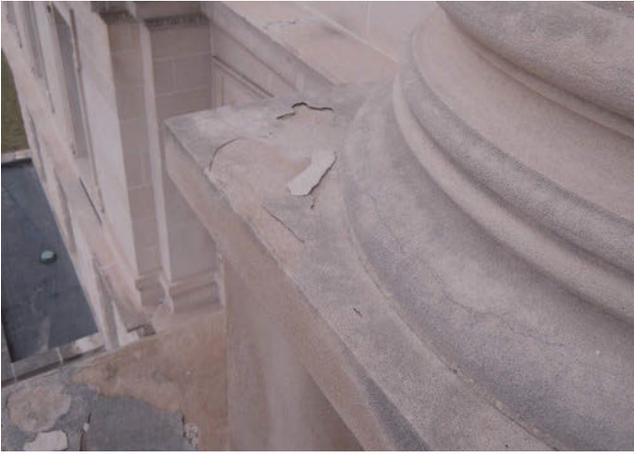
**Figure 4.** Spalled limestone fragments attributed to sealer applications that had previously been installed on the limestone.

Proper cleaning of stone necessitates identifying the stain or soiling that is to be removed, which may be dirt or other surface contaminants, efflorescence or minerals from the stone itself, biological growth, or other stains that penetrate into the stone. Past maintenance should be reviewed, as water repellents may have been introduced (Figure 4) that can in some cases trap stains

and alter the breathability of the stone surface, leading to material spalling or exfoliation. Each type of soiling may require a different cleaning strategy. Cleaning trials, including microscopic examination of the surface, are recommended
