# Second Chances: Discussion of Modified Wood

BY: TIMOTHY M. CROWE, ALA, SE, PE, FAPT

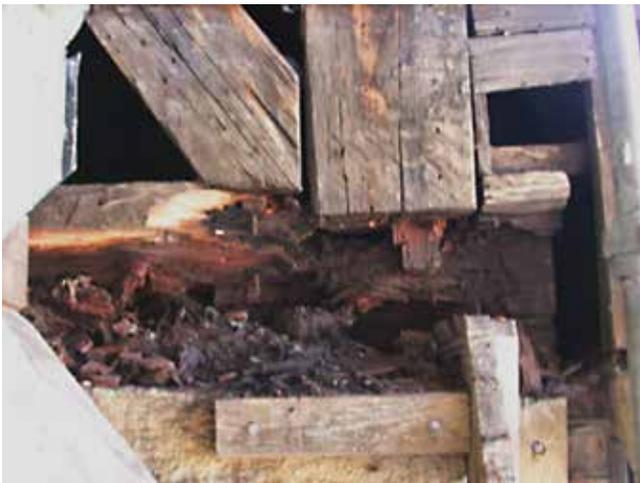
Figure 1. Advance decay in a timber framed bell tower (left) - (Crowe Photo).

**P**rior Second Chances articles have reviewed different challenges with the use and repair of wood systems. This article takes a different tack and discusses less common wood materials to consider when assessing your project. Selecting the correct treatment of wood materials for exterior decks, cladding, and structural uses creates challenges for designers and builders as they try to achieve a desired appearance and function while addressing wood vulnerabilities to moisture, decay and general durability (Figures 1, 2, and 3).

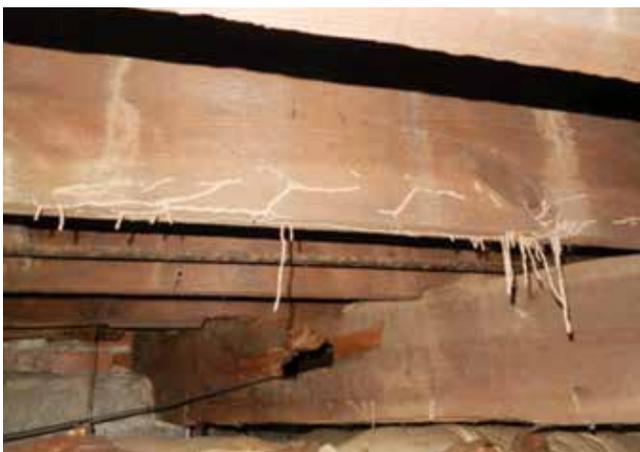
Figure 2. Advance decay and fruiting bodies in a newer multi-family housing development (right) - (Crowe Photo).

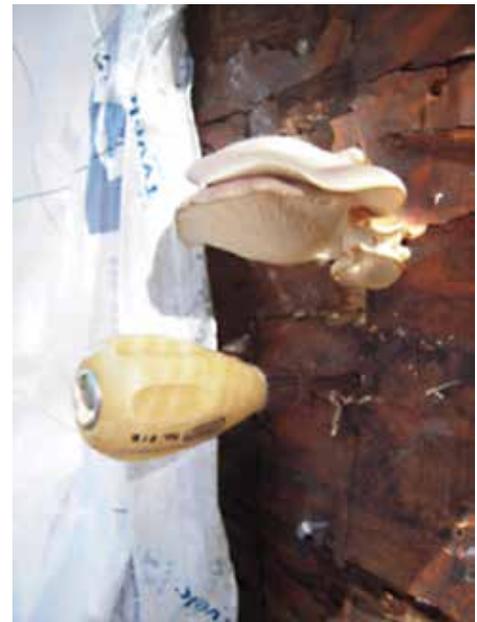
Figure 3. At lower moisture contents certain wood species are vulnerable to insects. (Crowe Photo)

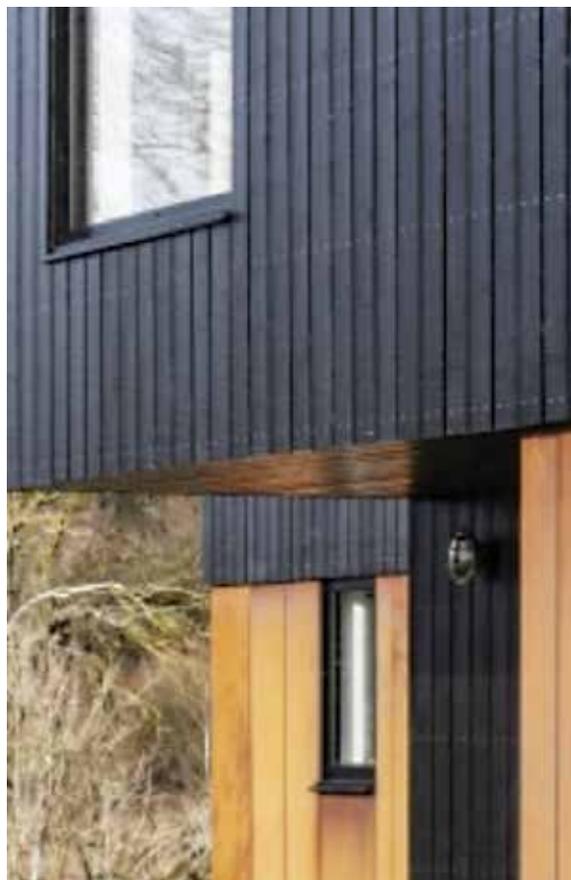
Figure 6 Image of Russwood Thermopine®, design by Fife Architects, photo by Keith Hunter.

With the elimination of chemical treatments and the removal of sugars, extractives, and moisture, the wood is also lighter and less dense. Unfortunately, there is also a reduction in strength that generally corresponds with the reduction in density. The treated material is generally marketed for wood siding and similar cladding/vertical surfaces uses that do not include ground contact (Figure 6). Manufacturers recommend coating this material for

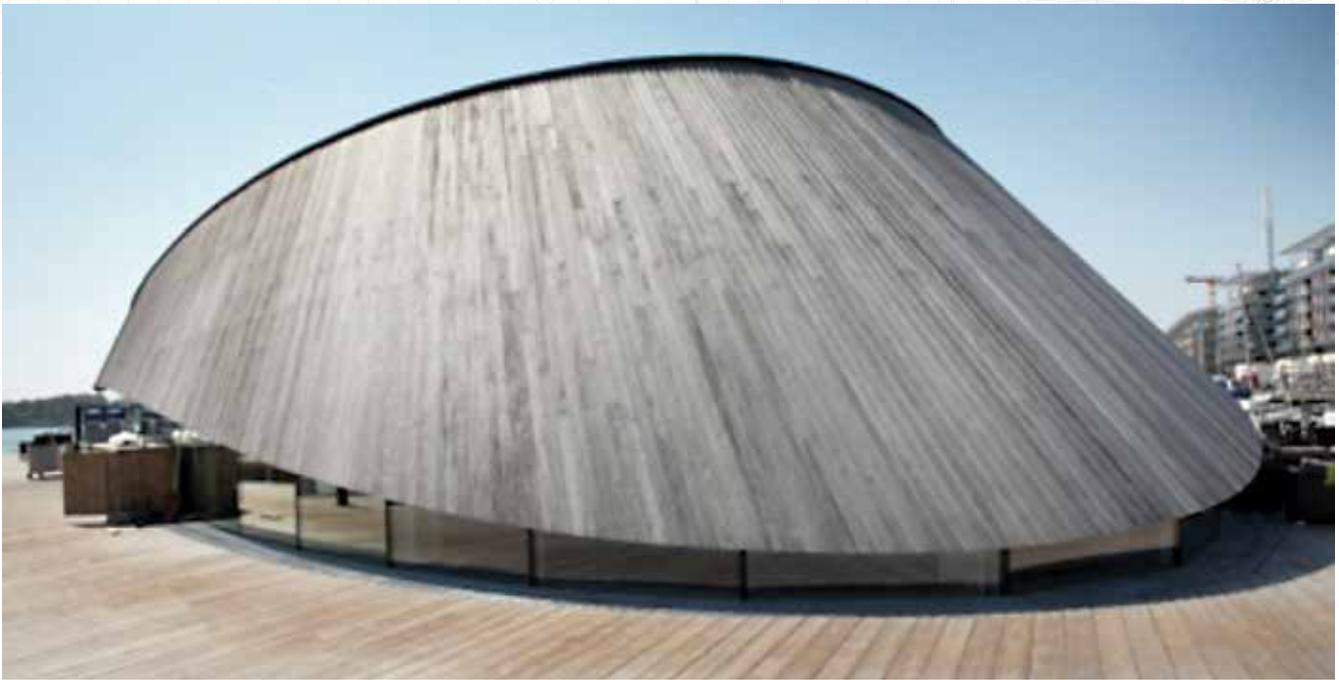
Figure 7. Photo courtesy of Kebony shows Kebonized wood cladding and decking (SYP) at Onda Restaurant in Oslo, Norway.

The modification process results in swollen wood cell walls that are no longer vulnerable to the prior ranges of shrinking and swelling. In addition, the changes that take place in the polymerization and thickening of the wood cell also creates a much harder wood material with increased density (~35%), and increased modulus of elasticity (MOE) and modulus of rupture (MOR) values. The feel of the end product is more consistent with that of teak or Ipe (also known as Brazilian walnut) rather than the southern yellow pine and/or maple parent material. This modified wood is widely used as exterior cladding on sloped and vertical surfaces (Figure 7) and is used as an alternative

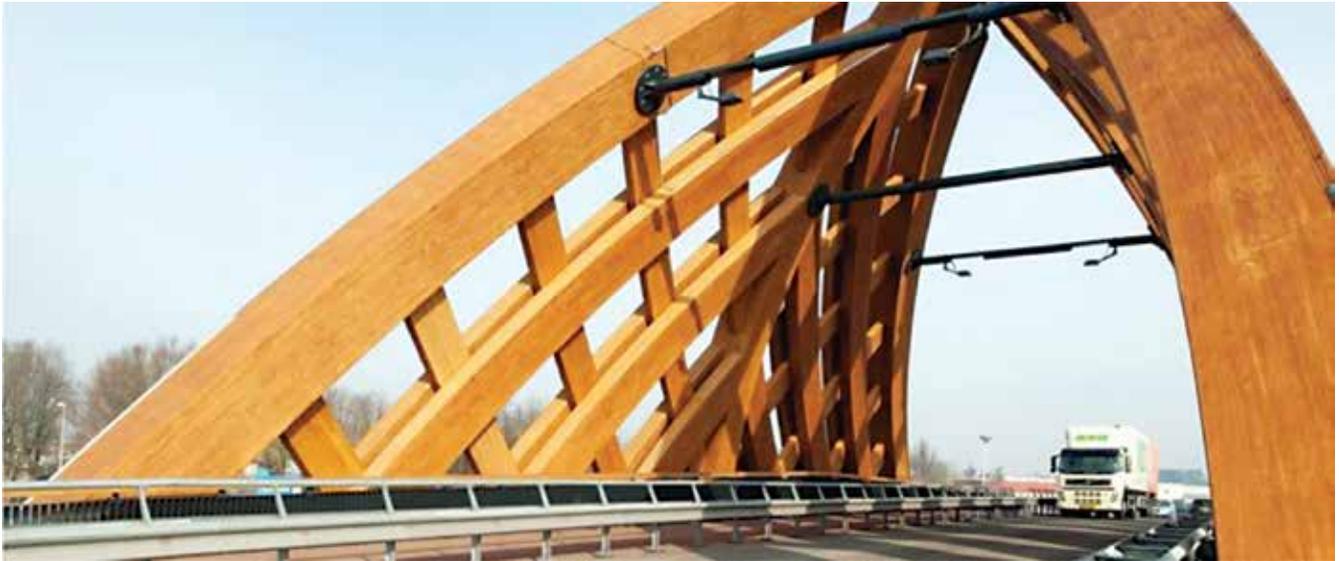
Figure 8. Wood bridge constructed with acetylated Accoya in Sneek, Netherlands Built: 2008-2010. (Photo Courtesy of Accsys)

cladding, wood decking and structural application (Figure 8). The product can carry a 50 year warranty above ground and a 25 year warranty with ground contact.
