Assessment and Repair Considerations with Indiana Limestone

BY TIMOTHY M. CROWE, ALA, SE, PE

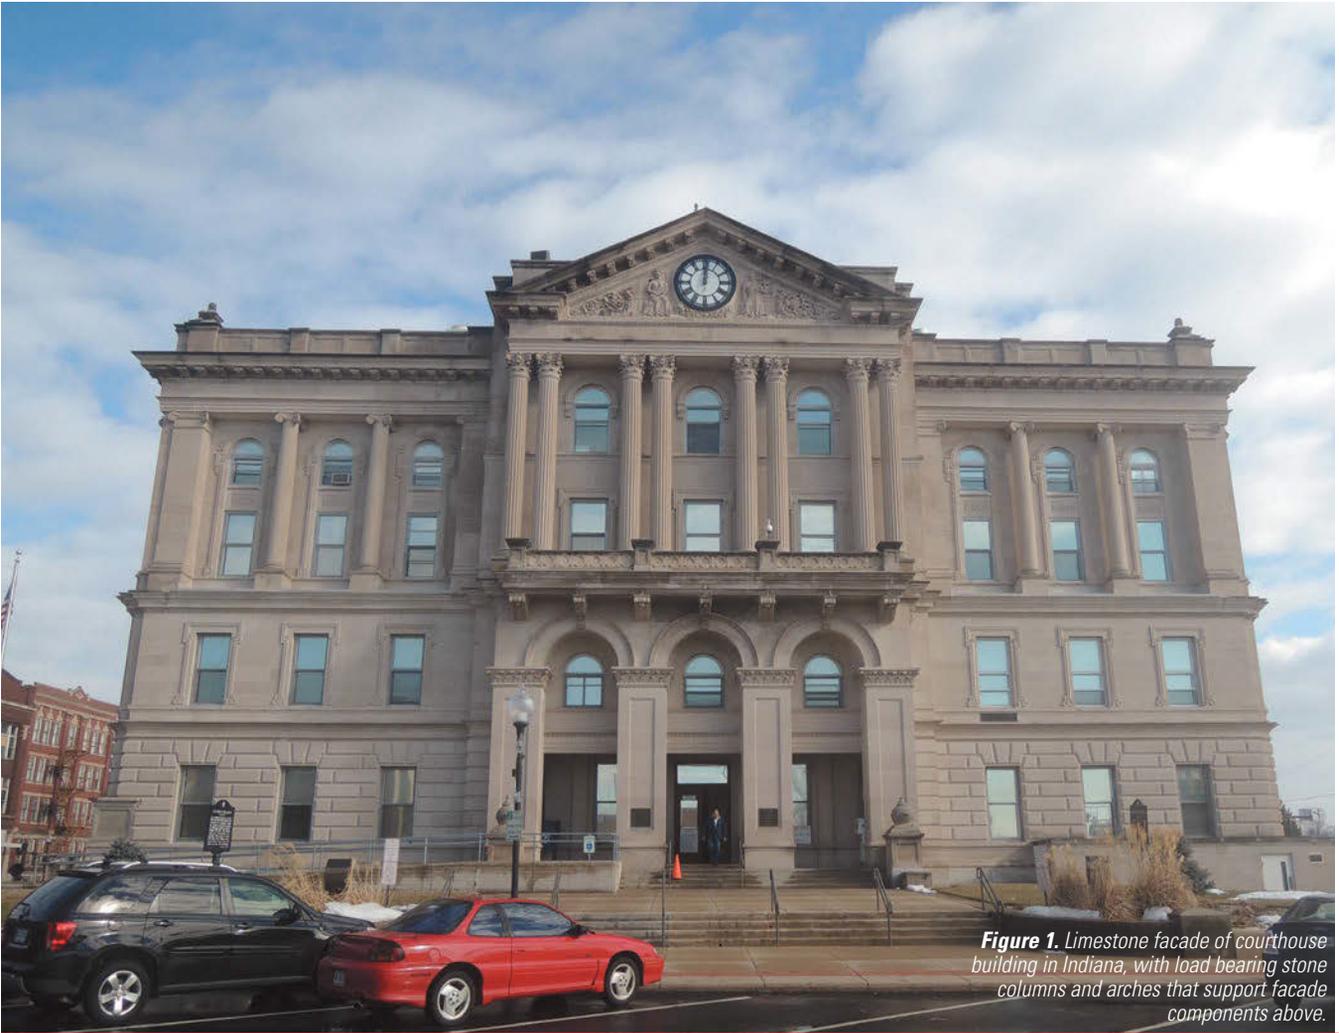
Figure 1. Limestone facade of courthouse building in Indiana, with load bearing stone columns and arches that support facade components above.

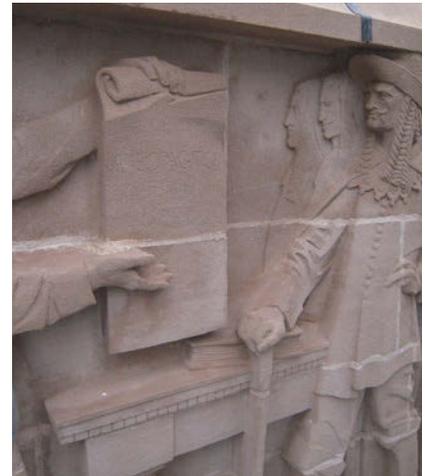
Figure 3. Example of stone carving on the Nebraska State Capitol that had been damaged by aggressive abrasive cleaning techniques as part of prior building maintenance. Note that the writing on the tablet is nearly gone.

Additional masonry maintenance concerns, not limited to Indiana limestone, include aggressive cleaning campaigns such as sandblasting or strong chemicals (acids) that can both degrade the stone and damage underlying support systems. In the mid-twentieth century, the unfortunate practice of sandblasting masonry facades as a cleaning practice was common. The end result was usually a loss of carving/detail on the stone (Figure 3), as well as a rougher surface that ironically is more vulnerable to dirt and biological growth accumulation.

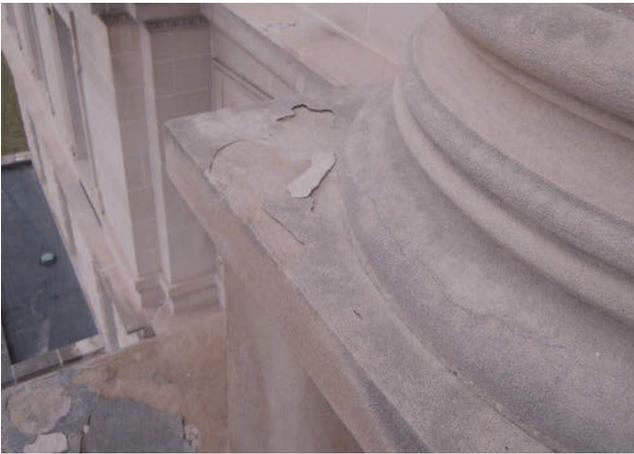
Figure 4. Spalled limestone fragments attributed to sealer applications that had previously been installed on the limestone.

Proper cleaning of stone necessitates identifying the stain or soiling that is to be removed, which may be dirt or other surface contaminants, efflorescence or minerals from the stone itself, biological growth, or other stains that penetrate into the stone. Past maintenance should be reviewed, as water repellents may have been introduced (Figure 4) that can in some cases trap stains

and alter the breathability of the stone surface, leading to material spalling or exfoliation. Each type of soiling may require a different cleaning strategy. Cleaning trials, including microscopic examination of the surface, are recommended
