PROJECT PROFILE

135 Bishopsgate

Building Enclosure Condition Assessment and Restoration | London, United Kingdom

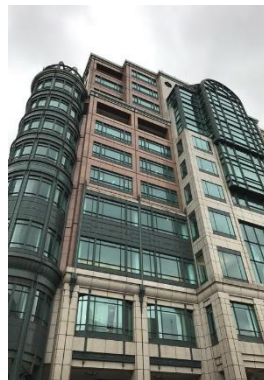
WJE performed a close-range survey and assessment of representative sections of the above-grade exterior wall and roof systems and assemblies in support of the ongoing cleaning and refurbishment. Material samples were removed for laboratory analysis. WJE also performed mock-up in situ cleaning studies to identify the most responsive method of cleaning for the stone veneer, painted metal framing, spandrel panels, and glass surfaces.

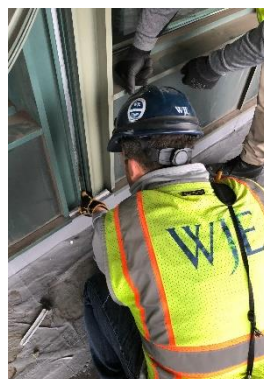
Field testing for water penetration resistance was performed at representative locations throughout the property. Flood testing and hose testing were both successful in recreating leaks at observed water staining locations. Infrared thermography was applied informally to gain a general understanding of the potential thermal bridging and air leakage at the exterior wall assemblies. Inspection openings were also made at the roof level to observe concealed conditions.
