PROJECT PROFILE

605 Waterford Garage

Condition Assessment | Plymouth, MN

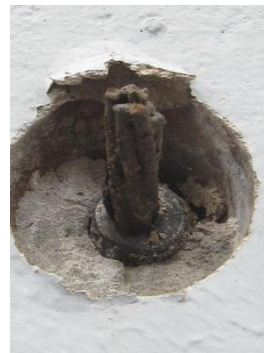
After acquiring the 605 Waterford Parking Garage in 2005, CB Richard Ellis noticed that water leakage was occurring through the upper level deck at expansion joints and the brick pavement area. In addition, two failed post-tensioning tendons were observed. WJE was retained to perform a condition assessment of the garage and to provide general recommendations for the necessary repairs.

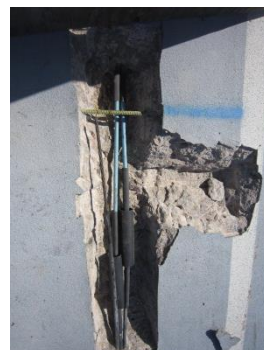
Construction observations were subsequently performed during the repair of the two failed post-tensioning tendons.
