# Arab Potash Company

Replacement of Deteriorated Concrete Slab | Ghor El Safi, Jordan

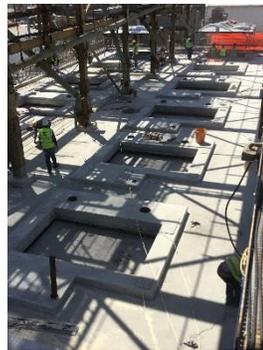
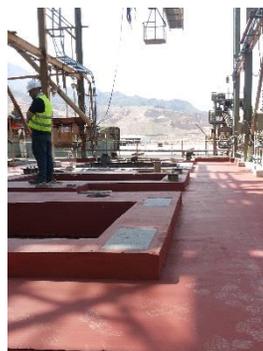
Long-term exposure to hot leach product (HLP) led to advanced deterioration of the concrete slab and supporting steel framing as well as deterioration of the concrete surface paste and corrosion of the embedded reinforcing steel. The supporting steel beams, columns, and bracing members exhibited advanced localized corrosion where the HLP product was allowed to pond. WJE was tasked with designing a replacement concrete slab capable of resisting the deleterious effects of the HLP while being able to support the dynamic loads from the centrifuge machines.
