PROJECT PROFILE

Life Time Fitness

Roof Moisture and Debonding Membrane Investigation | Beachwood, OH

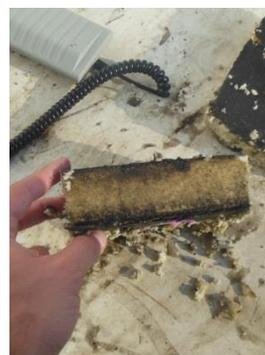
A year after the building was completed, the original TPO roofing system over the indoor pool area and several interior spaces to the north of the pool were replaced due to moisture-related problems. A few years later, the new fully adhered roofing membrane above portions of the indoor pool and adjacent spaces became un-adhered from the underlying insulation board, and water stains became evident in the pool area. WJE was retained to investigate the causes of moisture-related issues and debonding of the single-ply roofing membrane.

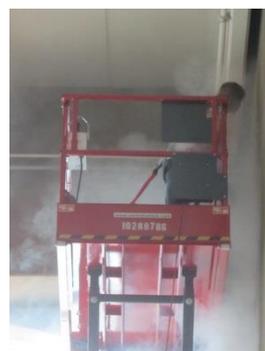
WJE performed a condition assessment; indoor moisture survey; infrared thermography of the exterior facade, roofing, and interiors; air exfiltration testing using a blower door, digital manometer, and smoke generators; temperature and humidity measurements; and roof test cuts. Based on the investigation, WJE determined the causes of the moisture-related issues and debonding roofing membrane to be primarily related to discontinuities in the vapor retarder, missing air seals, and over-pressurization of the pool area. WJE prepared a detailed report summarizing the causes of the excess moisture within the roofing assembly and debonding roofing membrane. Recommendations to repair deficient conditions and mitigate future distress included replacement of the roofing system, including the wet insulation; repair of the copings; installation of interior seals at the pool area; and adjustments and rebalancing of the pool HVAC system.
