PROJECT PROFILE

Denison Travel Center

Water Infiltration Investigation | Denison, TX

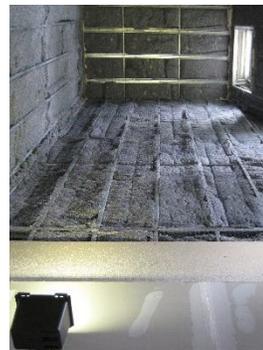
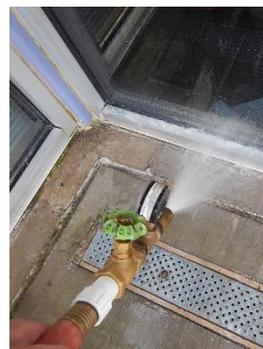
To identify the sources of water infiltration, WJE first conducted a visual survey of the interior and exterior of the Travel Center to find evidence of water infiltration and to identify conditions that could be contributing to the ongoing water infiltration. WJE then employed a regimen of spray testing to identify and confirm the sources of water infiltration. Once water infiltration was confirmed through spray testing, investigative openings were made on the interior and exterior to determine the deficiency that was allowing water to bypass the building envelope systems.

Fifteen different areas of water infiltration were identified—the majority of them caused by improper lapping of masonry through-wall flashing. Deteriorated gaskets and window sealant, improperly applied waterproofing membranes, failed and deteriorating sealants, and punctures in the roof membrane also contributed to the water infiltration. WJE provided schematic repair recommendations and an opinion of probable cost for the repairs.
