PROJECT PROFILE

Indiana War Memorial

Building Envelope Assessment and Repair | Indianapolis, IN

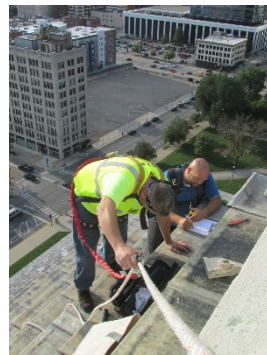
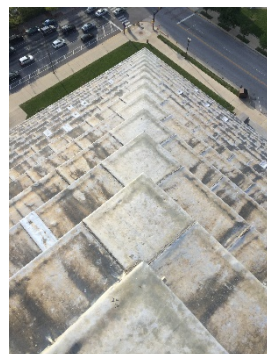
WJE's Difficult Access Team assessed the reported water infiltration and existing conditions at the interior and exterior areas. Investigative openings at locations in the exterior limestone and lead sheet flashing were utilized to identify the source of the leakage.

Based on WJE's assessment, water leakage into the interior of the building at the ziggurat steps was a result of defects and deficiencies in the original lead flashings, lead flat-lock panels, and low-sloped roofing systems. WJE also noted distress to limestone cladding units at the ziggurat resulting from corrosion of anchorage.
