PROJECT PROFILE

Indianapolis International Airport

Investigation of Fabric Canopy Failure | Indianapolis, IN

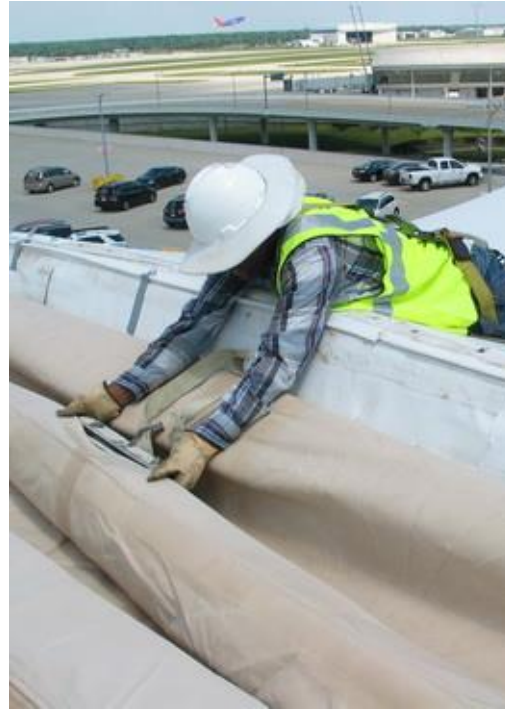
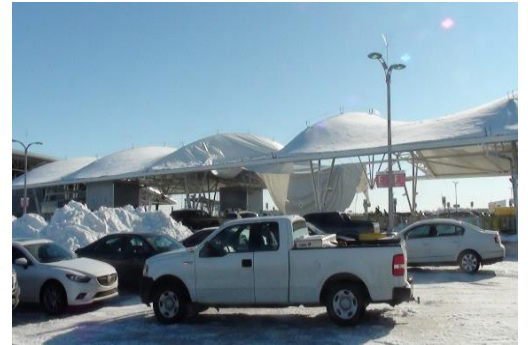
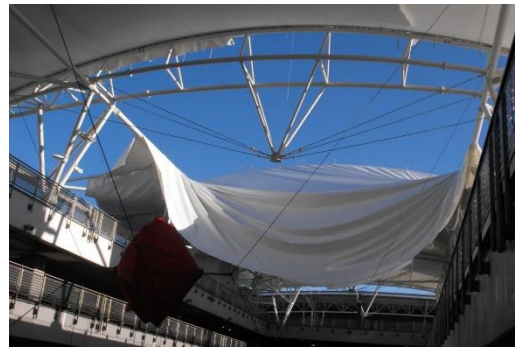
At the request of the Indianapolis Airport Authority (IAA), WJE investigated the February 2014 collapse of a fabric canopy at the main airport parking garage to identify the probable cause of the failure. An accumulation of snow, water, and ice was present on the top surface of the fabric membrane at the time of the failure. The fabric failed along an intermediate supporting truss, resulting in the collapse of a 5,400-square-foot bay of the canopy roof into the atrium below.

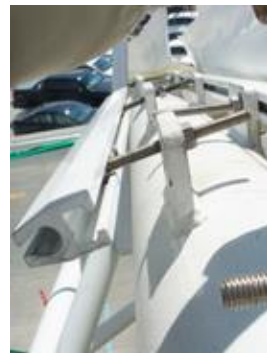
The collapse investigation included detailed visual examination of the structure and the failed membrane fabric, review of weather records, review of construction and previous repair documents, and calculations of expected stresses in the fabric at the time of the failure. Loads on the structure at the time of the failure were less than the minimum design loads specified by the building code, and no indications of fabric strength deficiency were identified. WJE concluded that the failure occurred as the result of improper installation of the membrane on the steel supporting structure, which allowed the connecting bolts to loosen over time and created stress concentrations in the fabric.

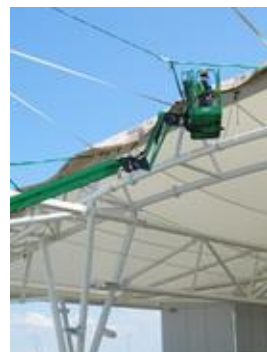
Following the collapse investigation, IAA retained WJE to conduct a detailed, nonlinear structural analysis and design review of the entire remaining membrane roof. Based on the findings of that review, WJE concluded that the existing roof, installed in accordance with the intent of the original design, was structurally adequate to resist code-prescribed design loads. In conjunction with the review, WJE provided recommendations for selective retrofitting of the panel edge attachments to minimize the likelihood of loosening of fasteners and misalignment of the aluminum extrusion segments. WJE provided a peer review of the contractor's repair and performed site visits and related construction-phase services during implementation of the repairs and retrofits.
