PROJECT PROFILE

224 South Michigan Avenue (Santa Fe Building)

Facade Inspection and Repair Design | Chicago, IL

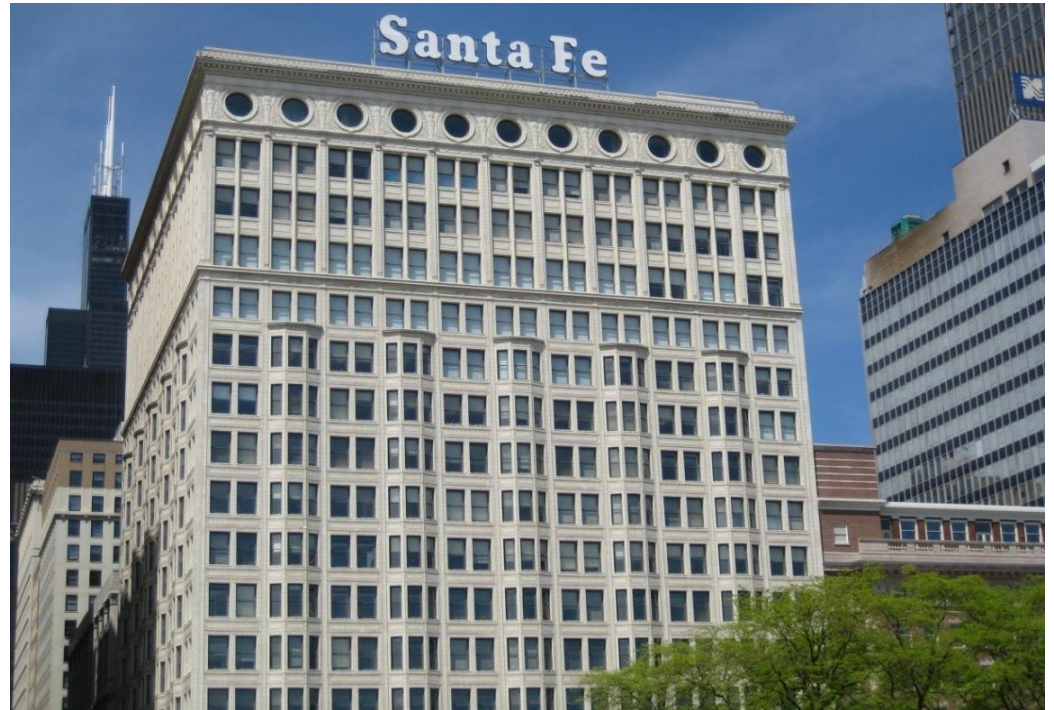
Originally known as the Railway Exchange Building, the Santa Fe Building was designed by Daniel Burnham and constructed in 1904. Located at the intersection of Jackson Boulevard and Michigan Avenue, the building measures approximately 172 feet by 172 feet in plan. The building is sixteen stories with an attic at the seventeenth floor and is clad with ornate terra cotta, metal windows, brick masonry, and a non-masonry material known as micro-cotta. A projecting terra cotta cornice extends around the east, west, and south facades of the building above iconic portal-like windows on the seventeenth floor.

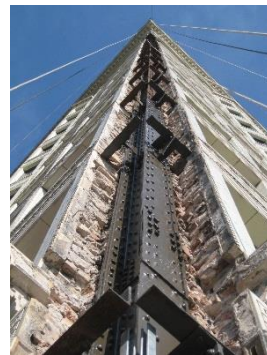
WJE was initially retained to provide a code-required facade inspection for this iconic building on Michigan Avenue. After distressed terra cotta units were identified on the building, WJE provided services to evaluate potential causes of the cracking and recommend repairs to address the distress in the facade.

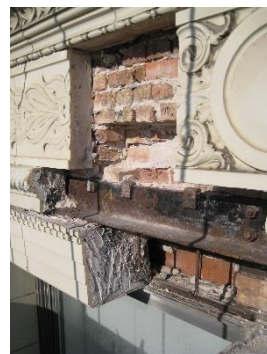
WJE masonry experts performed an inspection of the facade to evaluate potential causes of distress. During the initial inspection of the east and south facades, distressed terra cotta units were strapped as a precaution. WJE experts then performed in-situ strain relief testing to assess the stresses within the terra cotta, which revealed that some load had been transferred between floors yet was not accumulating over the height of the building. WJE's repair consisted of pinning terra cotta units, replacement of cracked units, and cutting of relief joints to relieve stresses within the terra cotta units.
