# Texas Governor's Mansion

Materials Assessment of Load-Bearing Masonry Walls | Austin, TX

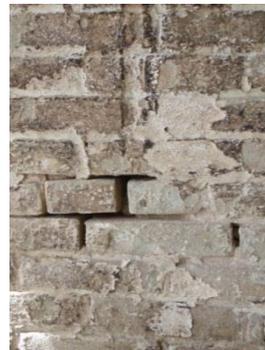
On June 8, 2008, the mansion, which was under renovation, was significantly damaged by a fire. During the post-fire assessment, concern developed regarding the structural integrity of the load-bearing brick masonry walls. Terracon Consultants, on behalf of the Texas Facilities Commission, retained WJE to assess the original 1856 portion of the building and the interface of the original portion with the 1914 addition.

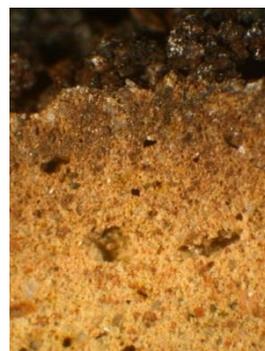
WJE performed a limited visual survey of the load bearing masonry walls at the original portion of the mansion to document preexisting distress as well as fire-related distress. WJE used nondestructive reinforcement location equipment to assess whether dowels were present connecting the bond beam to the masonry below. No evidence of dowels extending into the masonry was detected. WJE coordinated with the project team to select sample locations of plaster, mortar, and masonry for material testing and analysis. Representative bricks were selected for petrographic examination and compression testing.
