PROJECT PROFILE

Durfee Hall

Exterior Restoration | New Haven, CT

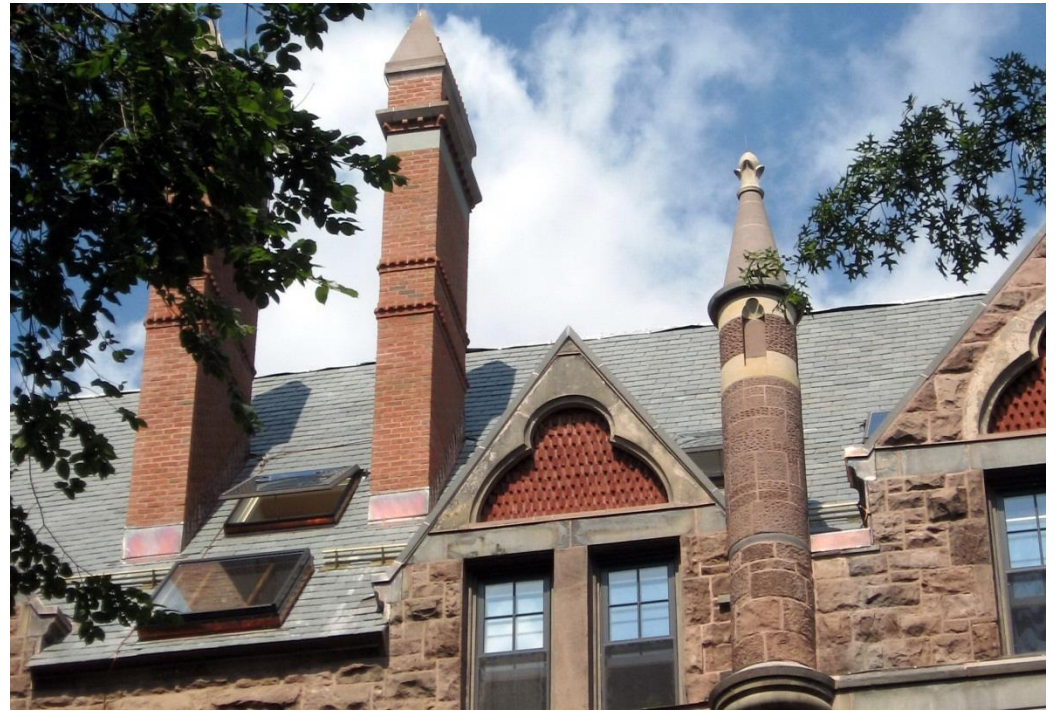
The instability of the stone turrets, scaling of the brownstone facade, spalling brick at the chimneys, falling slate, and decay at wood windows prompted Yale University to ask WJE to perform a condition assessment of the building exterior and to develop a restoration program.

From WJE's condition assessment, a design restoration program was developed that detailed the complete reconstruction of the turrets and chimneys, replacement of the slate roofing and copper flashing, brownstone repairs, and window replacement due to extensive damage caused by years of exposure to harsh New England weather conditions. The project was phased over summer seasons in order for building to remain functional as a dormitory for Yale University.
