PROJECT PROFILE

333 Bush Street

Structural Peer Review of a Modern Sculpture | San Francisco, CA

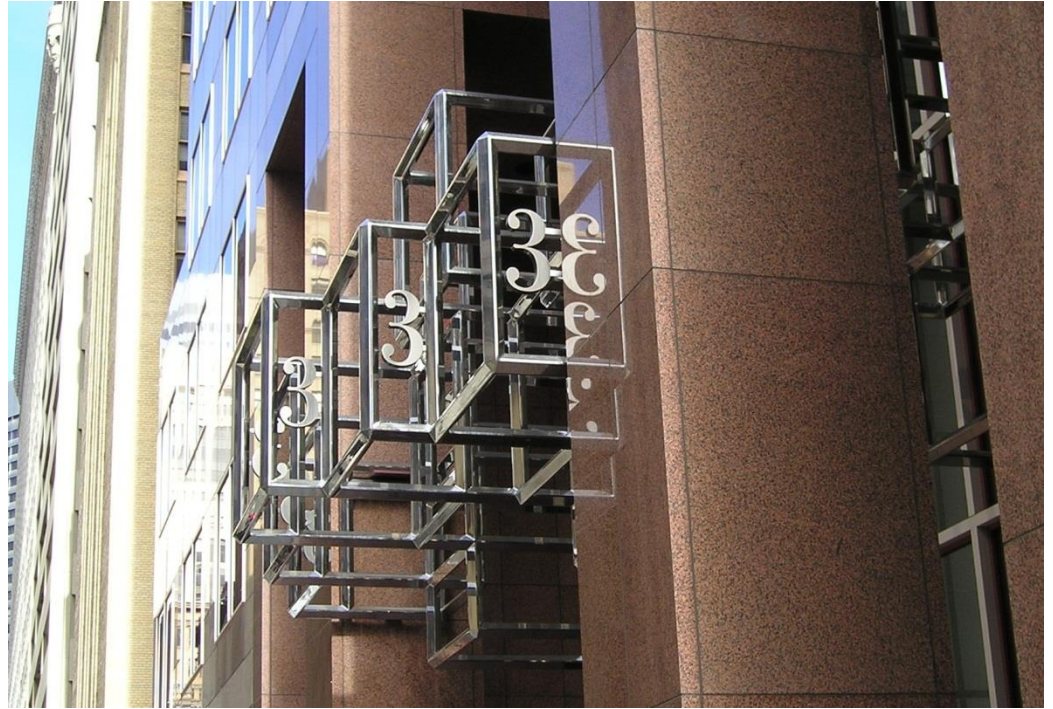
The modern sculpture consists of a fifteen-cube structure that hangs over the outside of the main entrance of the building and a smaller three-cube structure located just inside the entrance. The sculpture was added after construction of the building was complete.

WJE found that the sculpture framing was structurally sound but that the proposed connections to the building could not sustain the required level of seismic deformations. Recognizing that the original connections were sufficient for all but the most severe load cases, WJE worked with the structural engineer of record to design a simple, unobtrusive backup system that would “catch” the sculpture should a severe earthquake cause the primary connections to fail.
