Larkspur Parking Garage

Investigation and Repair Design | Larkspur, CA

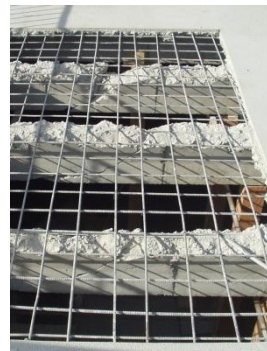
Soon after the vehicle height restriction was removed from the upper level of a parking structure, large cracks (up to 1/2-inch wide) were noticed in a number of the upper level concrete structural members. As a result of this damage, the Savoy Corporation had questions about the structure's immediate stability, the source of the damage, and what, if any, repairs would be needed.

Within a few hours of being contacted, WJE visited the site and designed emergency shoring to support heavily damaged members. A quick review of the structural system revealed that the entire garage had been designed to support typical automobile loading but that there had been no intent to allow anything larger on the upper level. Based on this information, WJE recommended that the height restriction be reinstated and assisted the owner in obtaining fire department approval to do so. WJE also designed repairs to the damaged joists and affected areas of waterproofing membrane.
