## Marina City Club Parking Garage

Distress Evaluation and Repair Design  
Marina del Rey, California

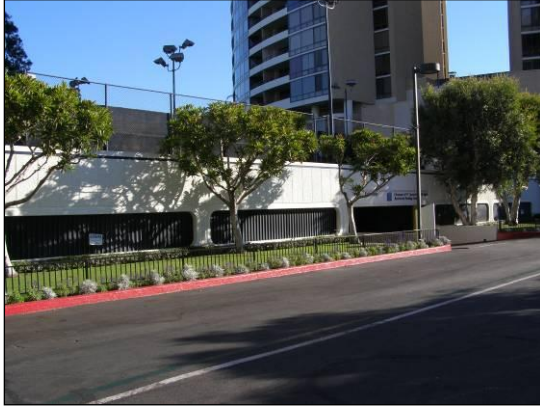
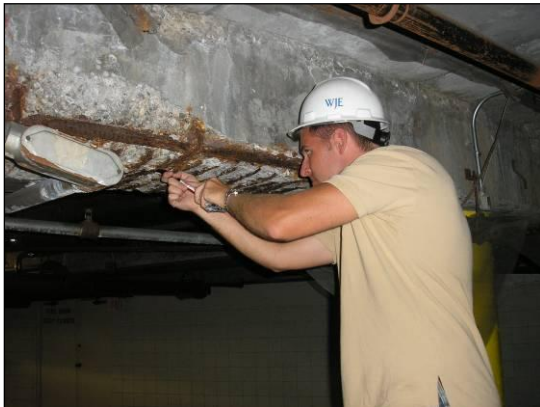
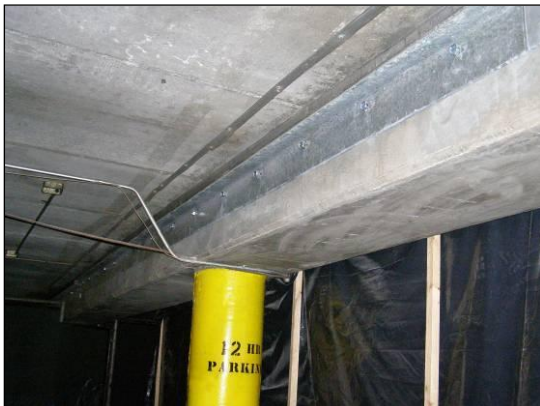
An assessment of the structure revealed damage to reinforced concrete elements from two primary sources: corrosion of embedded reinforcing steel due to chloride-contaminated water leaking from water softening equipment several stories above, and inadequate ledge bearing support for some precast concrete deck members. WJE developed simple, cost-effective measures to address the problems and assisted with their implementation.
