FRANKLIN AVENUE BRIDGE

ANALYSIS, DESIGN, AND ACCELERATED BRIDGE CONSTRUCTION

by Dan Enser, HNTB Corporation; Arne Johnson and Dr. John Lawler, Wiss, Janney, Elstner Associates Inc.; and Paul Backer, Hennepin County

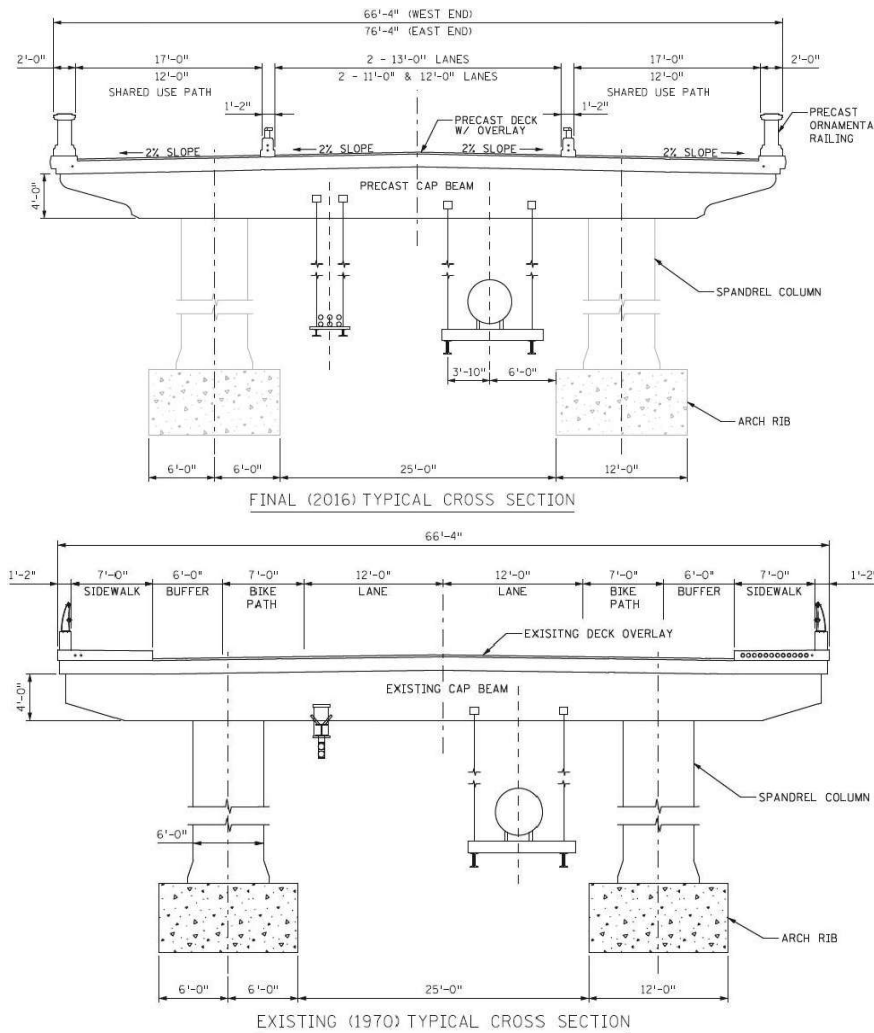
New (2016) typical cross section (top) and existing (1970) typical cross section (bottom). All Figures and Photos: HNTB Corporation.

- The bridge cross section was revised to accommodate a multimodal facility.
- Spandrel cap beams with historic scroll ends were used.
- Full-depth precast concrete deck panels were joined with ultra-high-performance concrete (UHPC).
- A premixed polyester polymer concrete (PPC) overlay was installed to protect the deck panels and construction joints from water ingress.
- Ornamental railing panels replicated the original 1923 design.

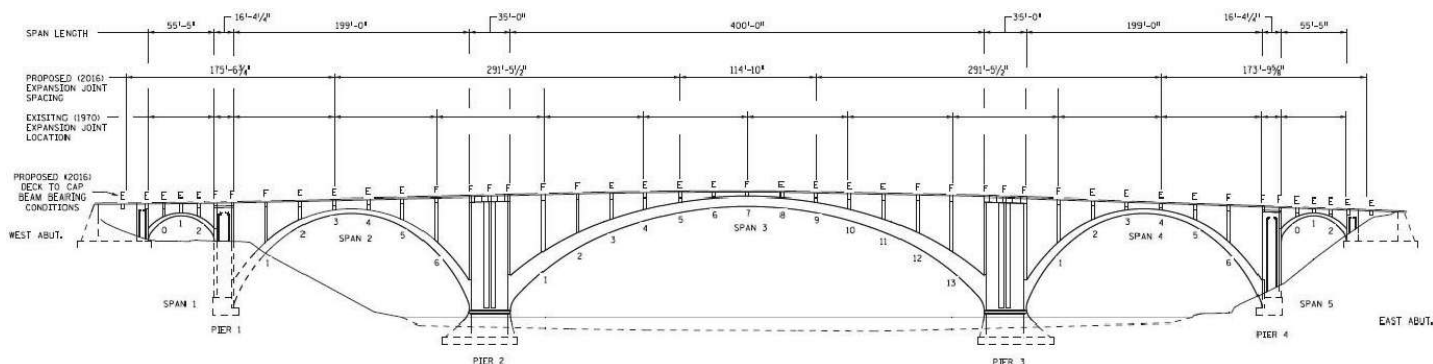
Bridge span layout with existing and proposed joint locations and deck-to-cap beam bearing conditions (E = expansion; F = fixed).

Reduction in the number of expansion joints was critical to extend the life of the structure. The greatest levels of degradation were found at the 15

existing expansion joints, which had allowed chloride-laden water direct access to the underlying, non-air-entrained original concrete elements. Reducing the number of expansion joints required a radical revision of the structural connectivity between the deck and cap beams. By allowing the deck to translate over the spandrel columns, the thermal forces within the spandrel columns and arch rib were greatly reduced. Releasing the connection between the deck and cap beams required a reliable, low-friction bearing assembly that would accommodate the translation associated with thermal movements.

strongly supported releasing the deck from the cap beams. While 15 of the existing expansion joints were removed, six were installed away from the substructure elements, reducing deterioration potential and extending bridge service life.

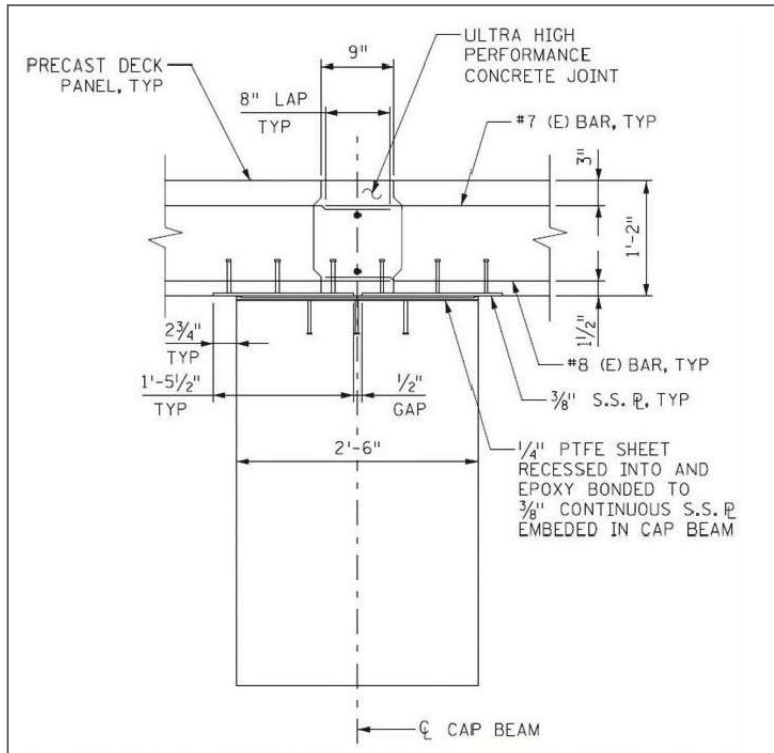
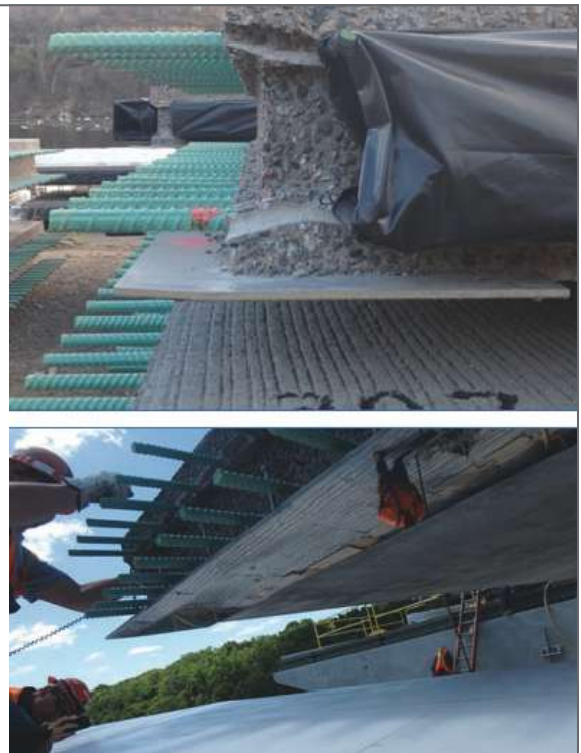
Typical sliding-plate joint and precast concrete deck panel joint.

A sliding-plate joint was developed, consisting of a polished stainless-steel plate embedded in the underside of the deck panels that slid on polytetrafluoroethylene (PTFE) bearing sheets recessed into stainless steel plates on top of the precast concrete cap beams. This innovative detail supported the deck loads and allowed the precast concrete deck panels to slide over the cap beams, offering minimal resistance to longitudinal translation.

Fortera building products manufacturing facility in Elk River, Minn., and the cap beams over piers were fabricated by the contractor. To facilitate the ABC approach, embeds to support temporary works and cap beam connectivity to spandrel columns were incorporated into the design. Cap beams at sliding and expansion joints had stainless-steel plates embedded in the top of the cap beam, with a recess of 1/8 in. for the PTFE sheets.

Innovative materials made the Franklin Avenue Bridge project feasible. UHPC allowed the deck to be continuous over the supporting cap beams with narrow joints between deck panels. The new cap beams, at 2 ft 6 in. wide, would not have accommodated traditional reinforcement bar splices without significant additional falsework. The rapid strength gain of UHPC allowed the contractor to move swiftly to the next erection step. The physical properties of UHPC, together with its material characteristics, provided a perfect application for this material. It is the first project in Minnesota to use UHPC to join deck panels and the second largest application of UHPC in the United States.

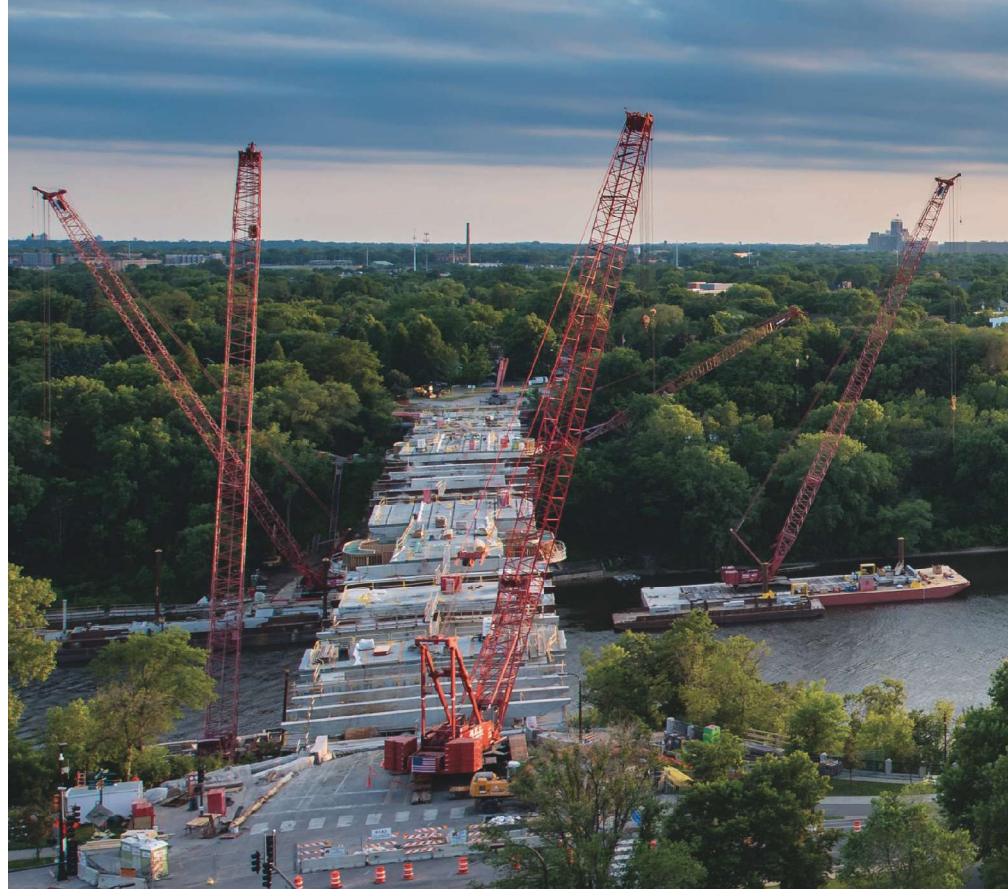
Accelerated bridge construction (ABC) operation.
