BY JEFFREY S. LEVINE

Wiss, Janney, Elstner Associates, Inc.

How changing atmospheric pollutants can discolor lead-tin-alloy-coated stainless steel roofing.

Red Lead Oxide Staining An Environmental Phenomenon

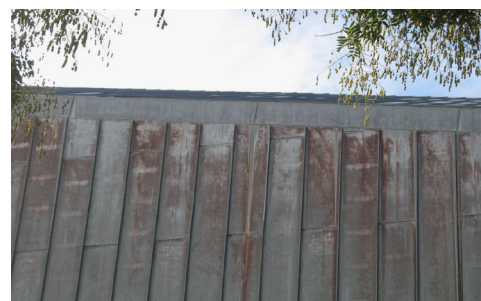
In the past, red oxide staining on TCS, or lead-coated copper for that matter, was primarily limited to rural and marine environments—so-called “pristine environments” with little pollution. With stricter environmental regulations in the later part of the twentieth century, there are fewer sulphates in the atmosphere and the problem of red oxide staining of lead-bearing metals is becoming more widespread. The formation of Pb_3O_4 —red lead—is favored in cleaner, less polluted air.
