# Retrofitting with High-Performance, Aluminum-Framed Window Systems

By Jean J. Wu

\*Retrofitting with High-Performance, Aluminum-Framed Window Systems\* authored by Jean J. Wu, was published in the August 2016 issue of the *Journal of the National Institute of Building Sciences* (JNIBS), a publication of the Washington, D.C.-based National Institute of Building Sciences. The article has been reproduced here with permission from the publisher. Learn more about JNIBS at <http://www.nibs.org/?page=journals>, and access your free issue(s) by subscribing at [http://www.wbdg.org/account/subscribe\\_inibs.php](http://www.wbdg.org/account/subscribe_inibs.php).

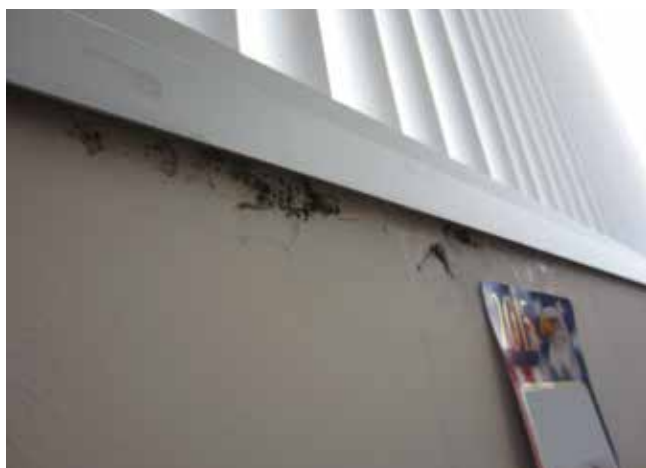
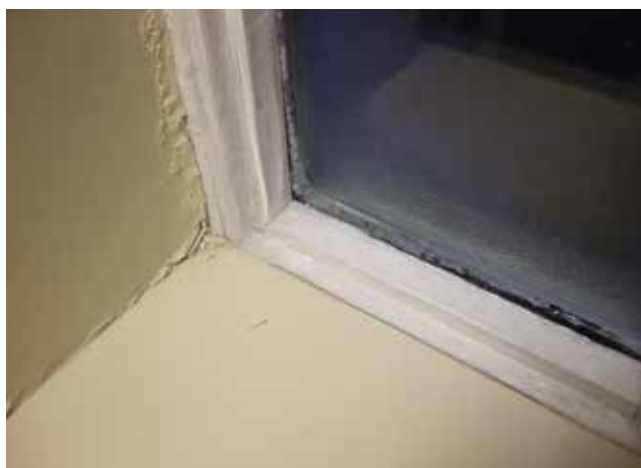
Typical thermal problems with existing window and wall systems include condensation and mold growth on interior finishes (left), as well as ice buildup on window frames and glass (right).

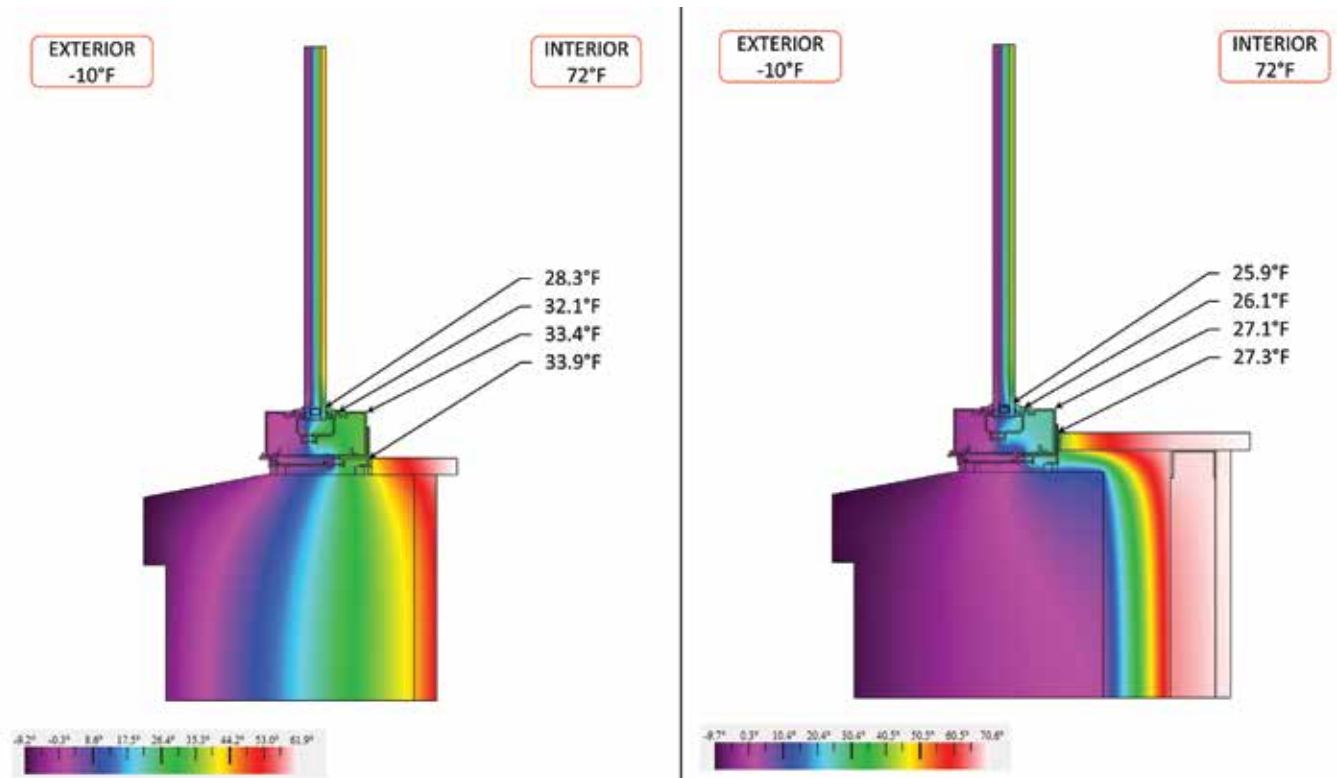
**Figure 1:** These illustrations offer a side-by-side thermal analysis comparison of storefront surface temperatures before (left) and after (right) insulation is installed at the interior side of a mass masonry wall.

The before-and-after thermal modeling images in “Figure 1” (see opposite page, top) illustrate the cooling effect of adding insulation to the interior of an existing mass wall system. Yet, when the window location is shifted to align with the new wall insulation, surface temperatures increase by more than six degrees at some locations (see “Figure 2,” opposite page). Aligning the thermal break within a window system with the plane of the wall insulation allows for the optimal thermal performance of both the window and the wall systems. This is why, when adding insulation to a wall system, it often is practical to remove and relocate/replace the window system (with revised detailing).

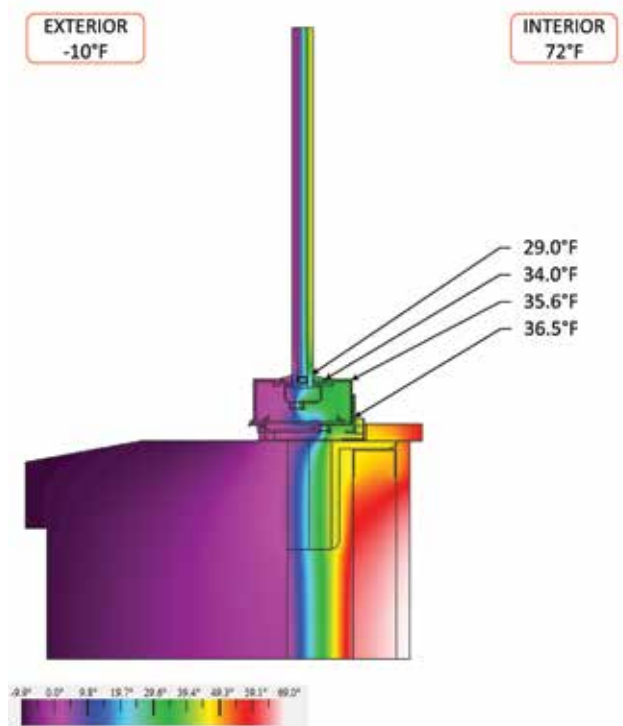
**Figure 2:** This thermal analysis shows the effect of shifting a storefront toward a building interior to align the thermal break with wall insulation.

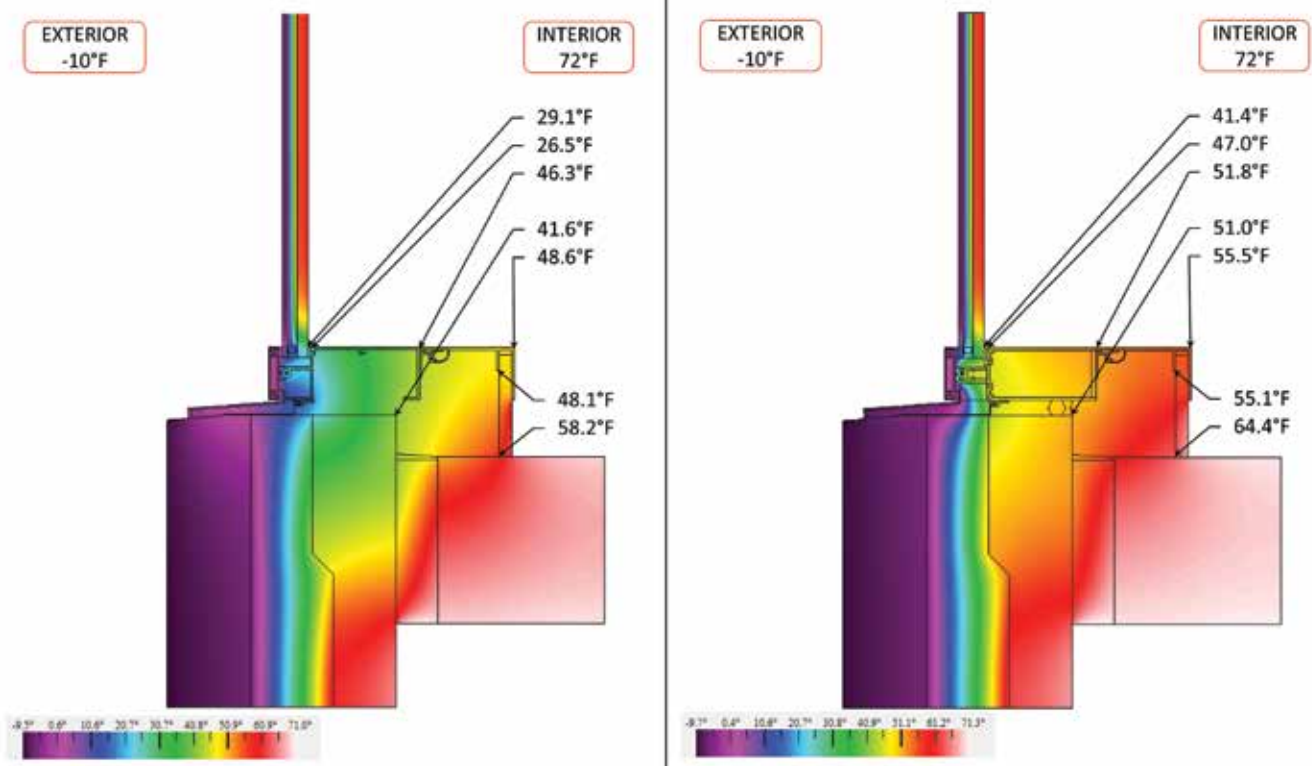
Figure 3: Different frame extrusions of the same curtain wall system are illustrated with side-by-side thermal analysis comparisons.

Designers assume a high-performance curtain wall system will perform well thermally. Sometimes, however, they overlook the fact that the curtain wall extrusion types may adversely affect the performance of the system. As shown in “Figure 3” (see above), two different extrusions of the same curtain wall system located at an insulated precast concrete wall panel can translate to a 20-degree difference in surface temperature at the interior. Even though the thermal break of the frame on the left side of the image is aligned with the insulation in the wall panel, a portion of the curtain wall frame extends towards the exterior and, combined with the sill cover, brings the cold to the interior portion of the frame. This could not have been detected without thermal modeling.

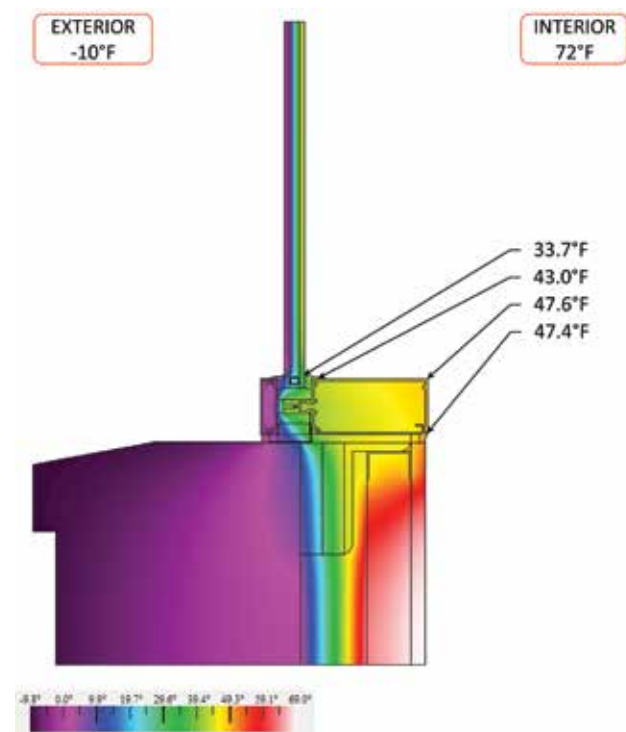
Figure 4: This thermal analysis provides the results of replacing the storefront in “Figure 2” with a curtain wall system.

the front of the system. The location of the curtain wall thermal break allows the majority of the curtain wall frame to be “warmed” by the interior conditioned air. This is why these curtain wall systems typically perform better thermally when compared to windows and storefronts, as shown in “Figure 4” (see page 13). “Figure 4” illustrates the surface temperature difference when the storefront system from the previous example is replaced
