106th Street Bascule Bridge over the Calumet River

Rack and Pinion Gear, Machinery Frame, and Counterweight Repair Design | Chicago, IL

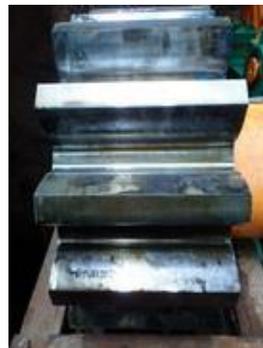
WJE identified significant misalignment of the northwest pinion drive shaft during the visual inspection and precision survey phase of the investigation. The existing location of the northwest machinery frame was found to be 1/2-inch forward of the ideal position. In addition, machinery frame distortion was identified along with severe rack tooth wear. Repair strategies were developed, and the "best value" option was selected by CDOT for implementation.

Structural and mechanical repair design was completed. Construction period services were then performed to assist the contractor in completion of rack tooth welded repairs to restore the existing teeth to their original profile, partial demolition and retrofit of existing machinery frame foundations, positioning of a new northwest machinery frame to provide optimal alignment/mesh with the repaired northwest rack teeth, and partial demolition and retrofit of existing leaf counterweight box.
