PROJECT PROFILE

Biloxi Lighthouse

Condition Assessment, Stabilization, and Restoration Recommendations | Biloxi, MS

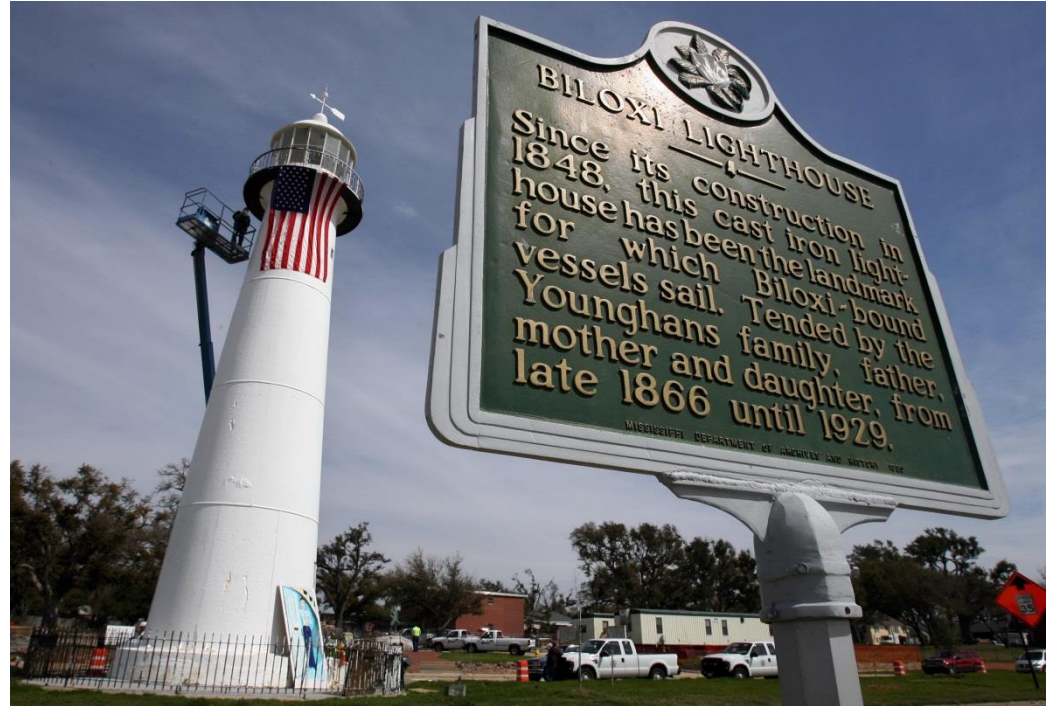
The Biloxi Lighthouse, completed in 1848, is the single remaining historic lighthouse of thirteen that once stood along the Mississippi Gulf Coast. The lighthouse, which is 53 feet in height above grade, is constructed with bolted cast iron cladding as a structural shell around a cylindrical brick internal structure. The lighthouse is a National Register property and a Mississippi Landmark.

After 150 years of service, the lighthouse withstood the storm surge that occurred during Hurricane Katrina in August 2005 but experienced a partial collapse of its interior brick lining. In cooperation with a local architectural firm, WJE performed a condition assessment and developed stabilization, repair, and restoration recommendations for the lighthouse to address both the recent hurricane damage and other deterioration related to aging and exposure.

WJE found the historic lighthouse in remarkably good condition given its age and coastal location. To address some corrosion on the exterior and interior ironwork, WJE cleaned the cast and wrought iron, removed the existing coating, and recoated the surfaces. The team also inspected and repaired corroded and fractured elements of the spiral stair system and lantern components.

Shoring installation was necessary to support areas of potentially unsupported brick masonry. In addition, the team replaced or restored missing or displaced brickwork in the interior shaft near the base and at the top of the lighthouse.
